**Snitz Creek 4 Stream Restoration and Stormwater Retrofit Project
Cornwall Borough, Lebanon County, Pennsylvania**

**Pennsylvania Department of Environmental Protection
Growing Greener Plus Grants**

December 2019

Snitz Creek #4 Stream Restoration and Stormwater Retrofit Project Detailed Project Description

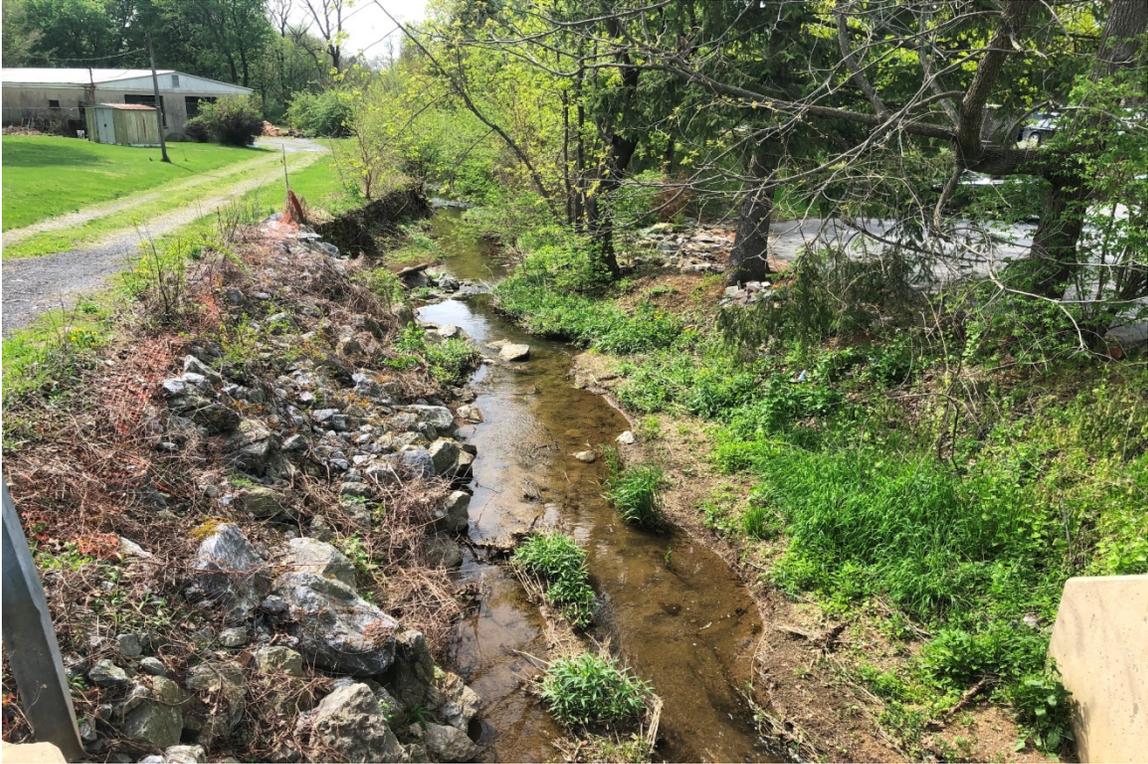
Looking downstream from Cornwall Road at upstream end of Reach 1

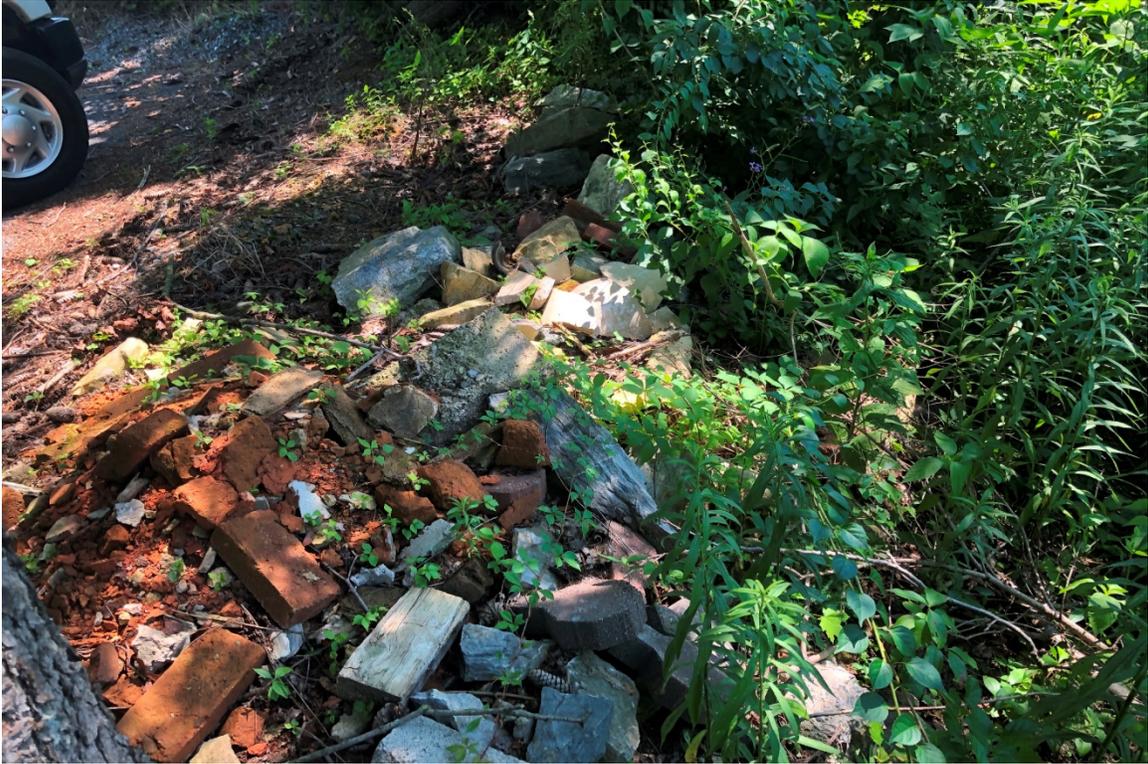
Rubble along right bank at edge of parking lot

- Removing the rip-rap and rubble from the right bank along the upper section and grading a bankfull bench to alleviate the confinement and provide flood relief.

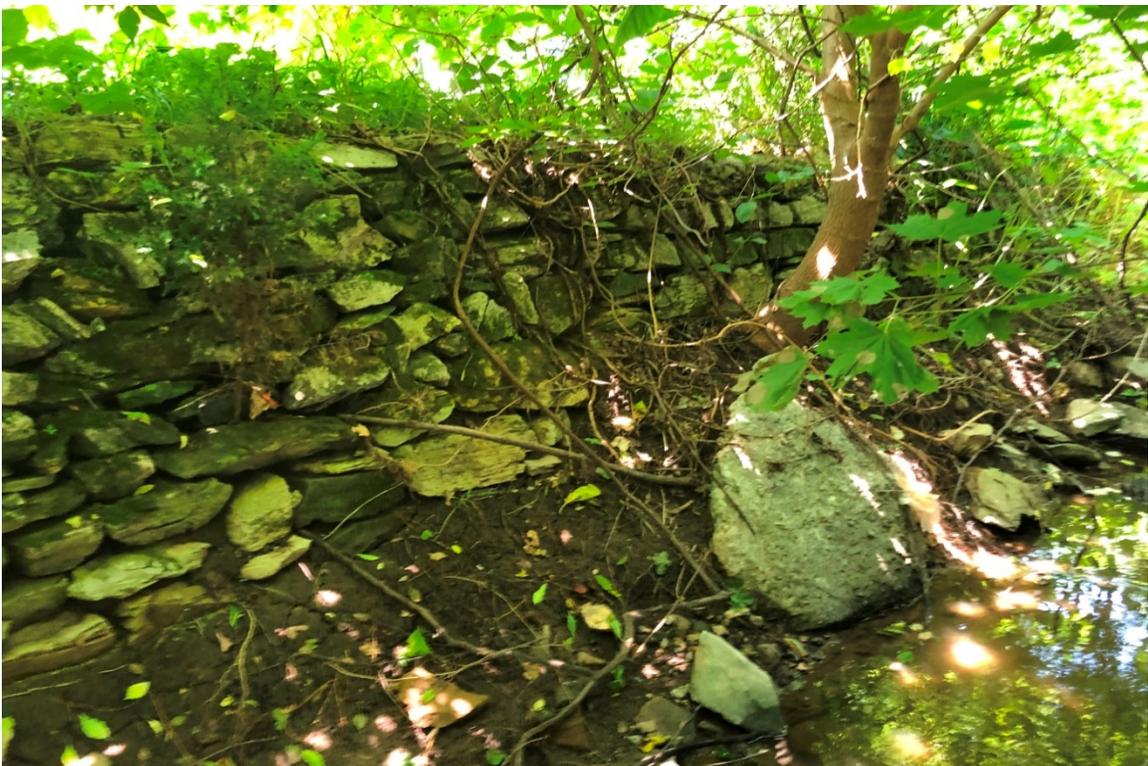
Old stone wall along left bank

- Removing existing debris jams and junk from the channel;
- Replacing the failing stone wall from the left bank along the upper section with an imbricated rock wall.

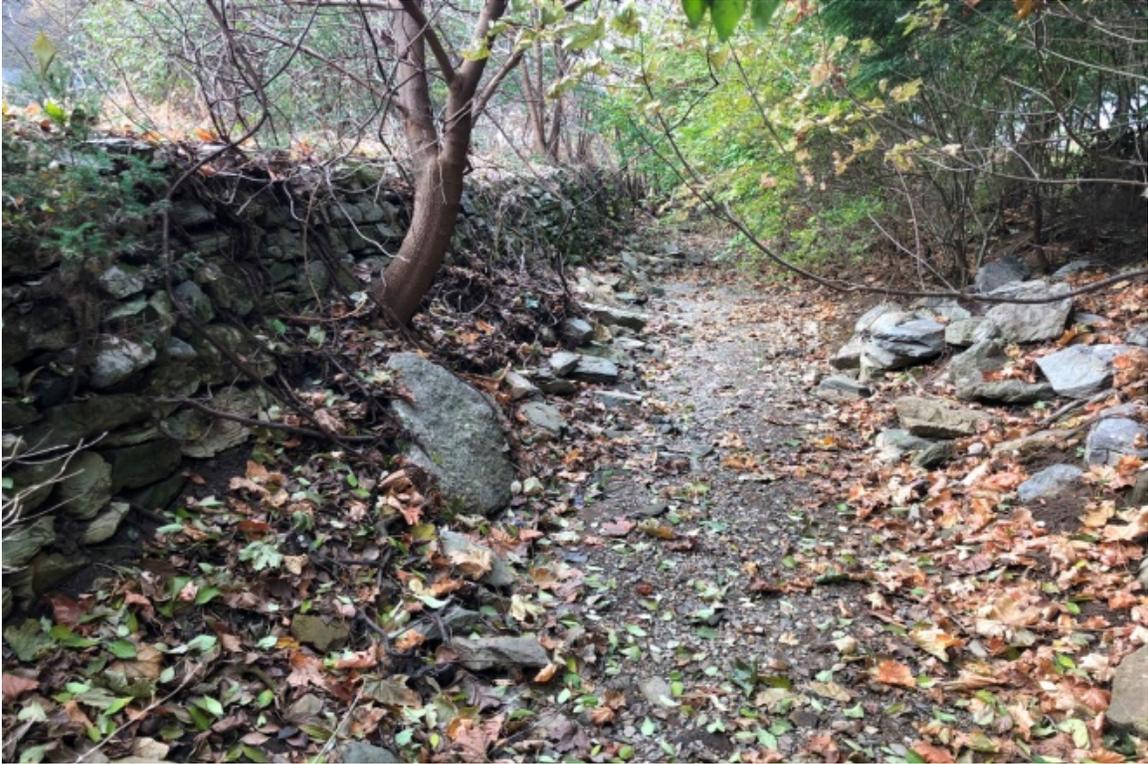
Channel confined by stone wall along left bank and rip-rap along right bank

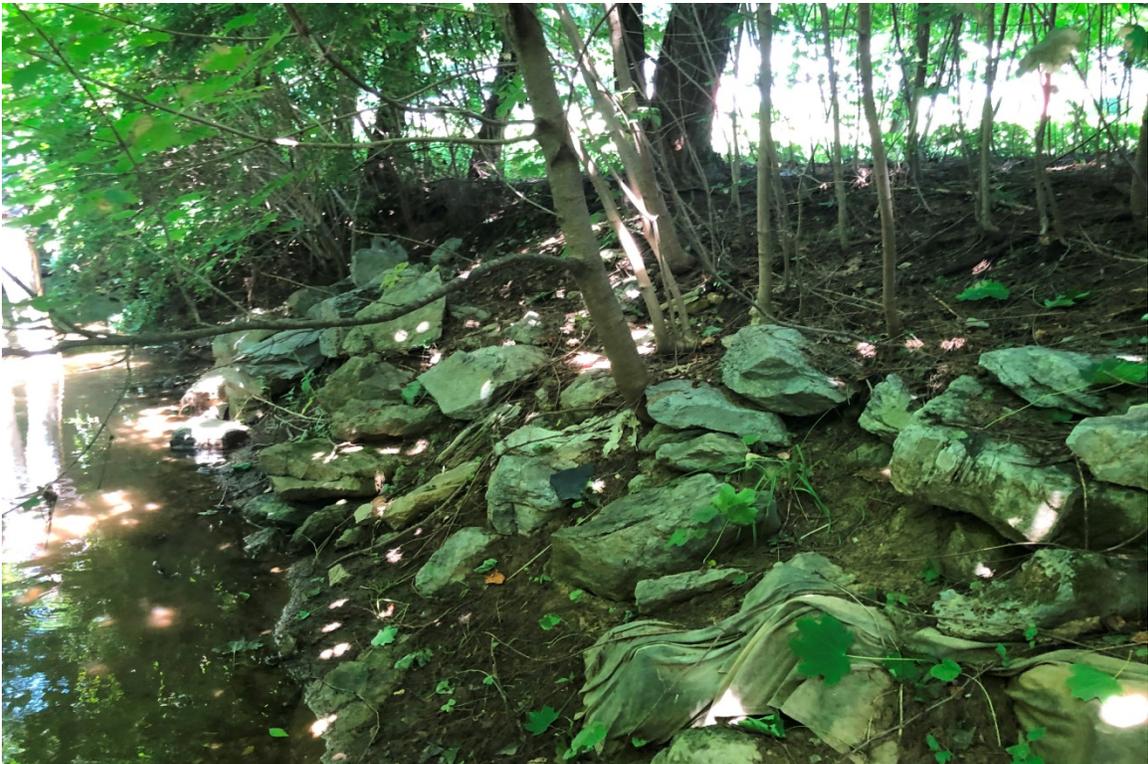
Rip-Rap failing along right bank

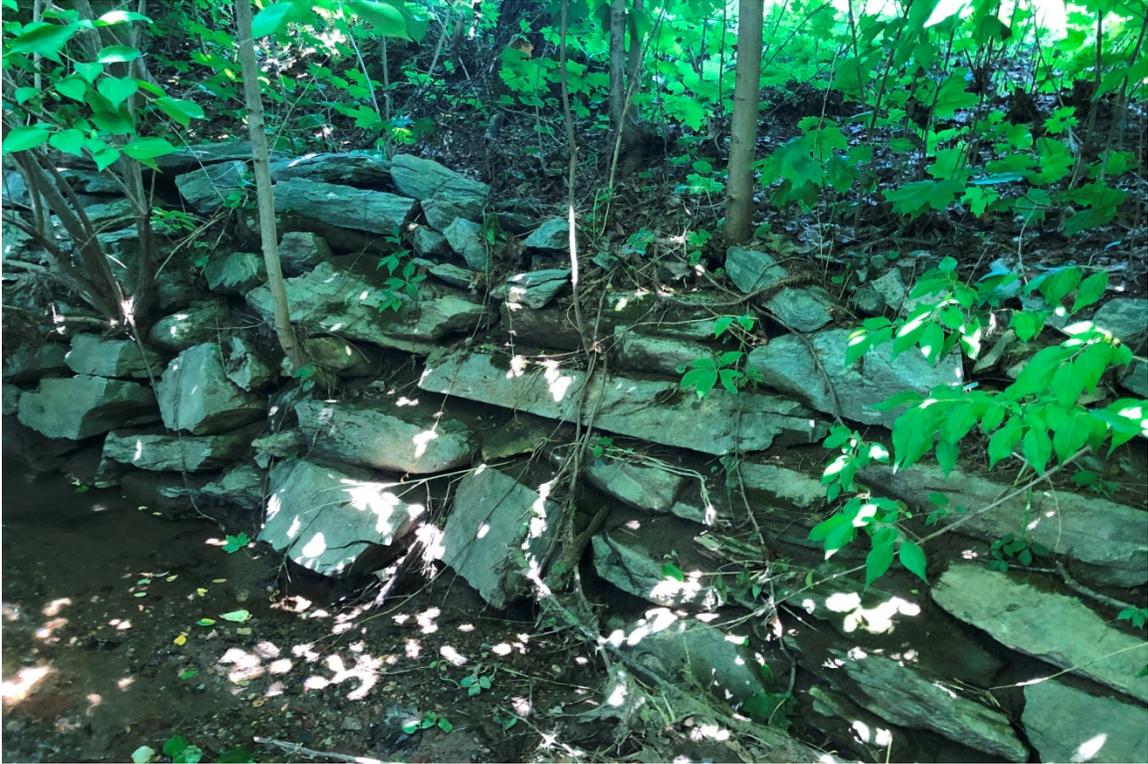
Stone wall failing along left bank

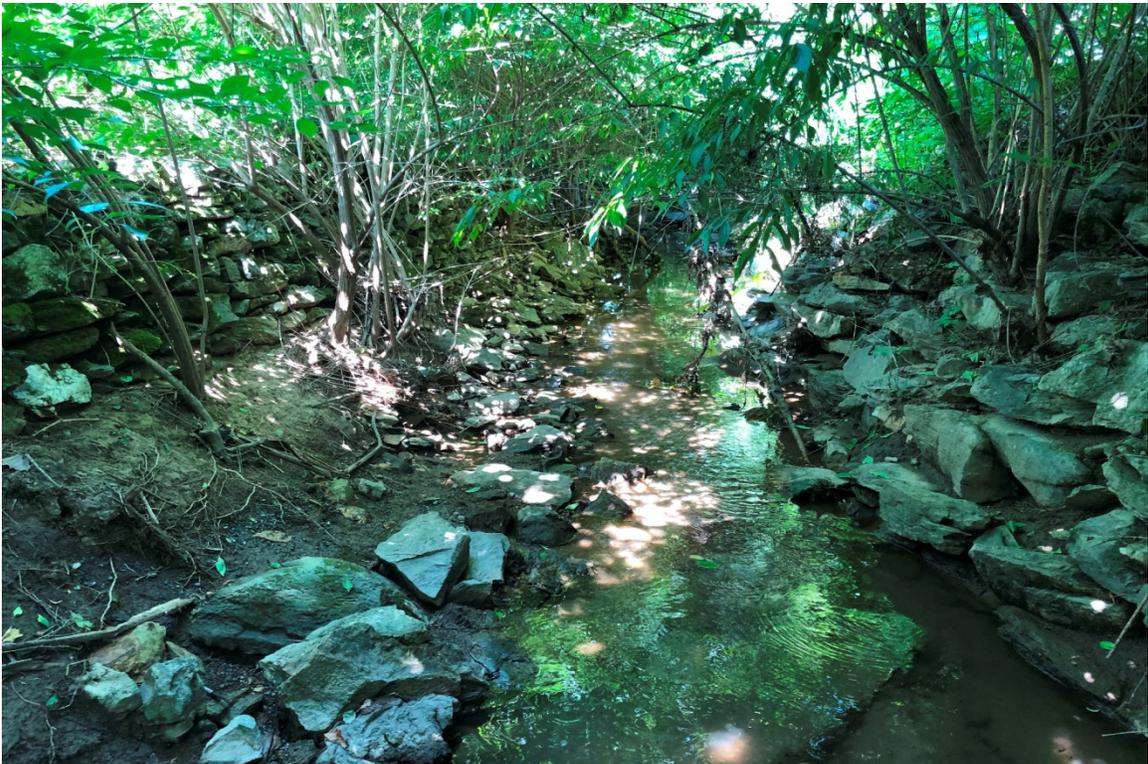
Channel confined by stone walls along both banks. Note rip-rap washed in from upstream

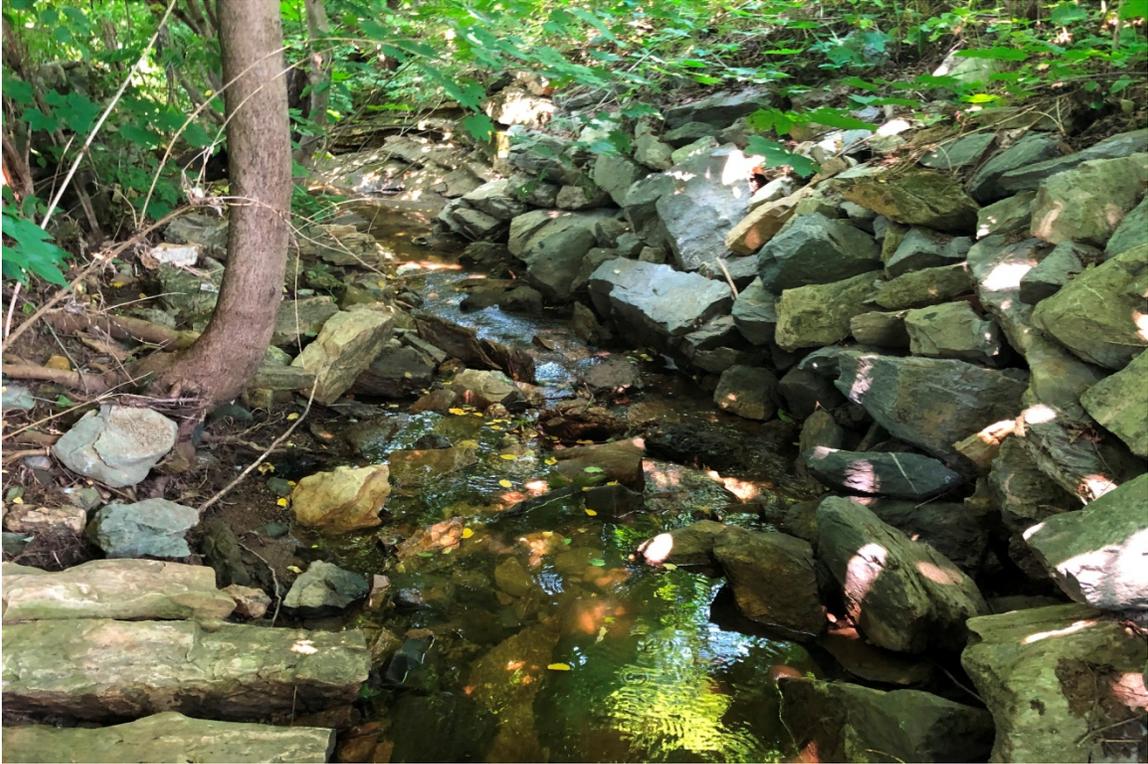
Channel confined by stone wall along left bank and rip-rap along right bank

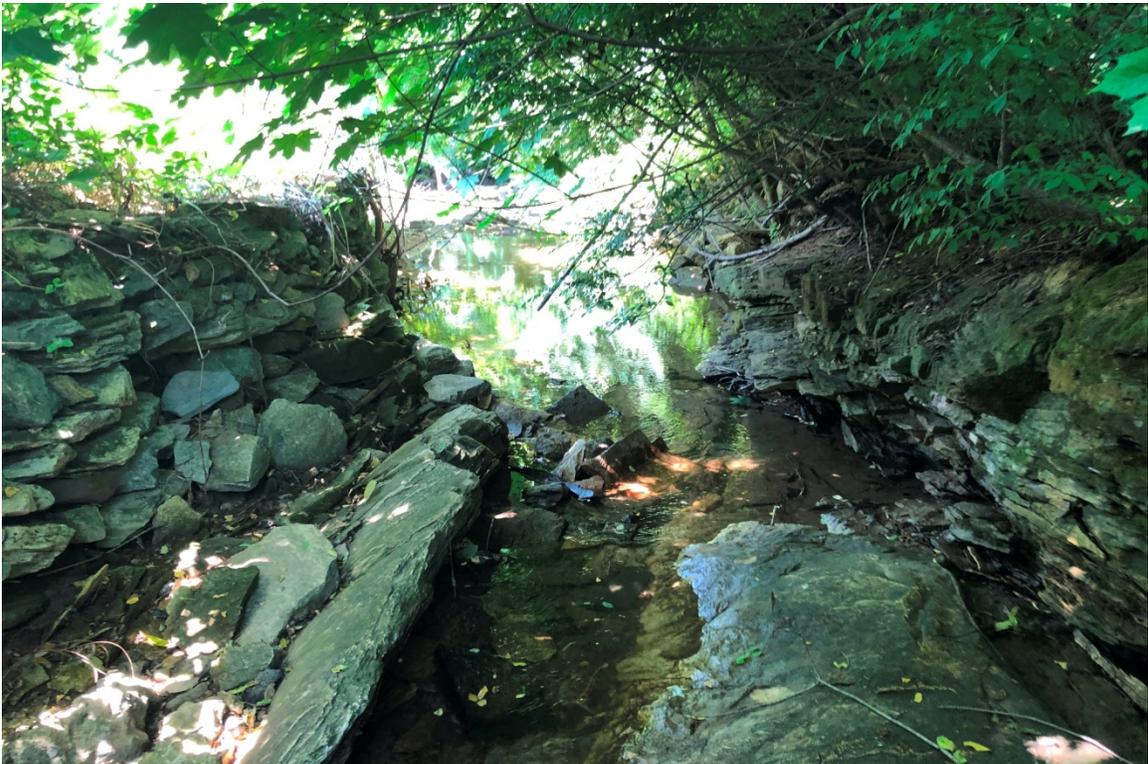
Channel confined by stone wall along left bank and bedrock outcrop along right bank

- The existing rock outcrop along the right bank along the middle section will be left undisturbed.
- Replacing the failing stone wall and rubble from the left bank along the lower section with an imbricated rock wall.

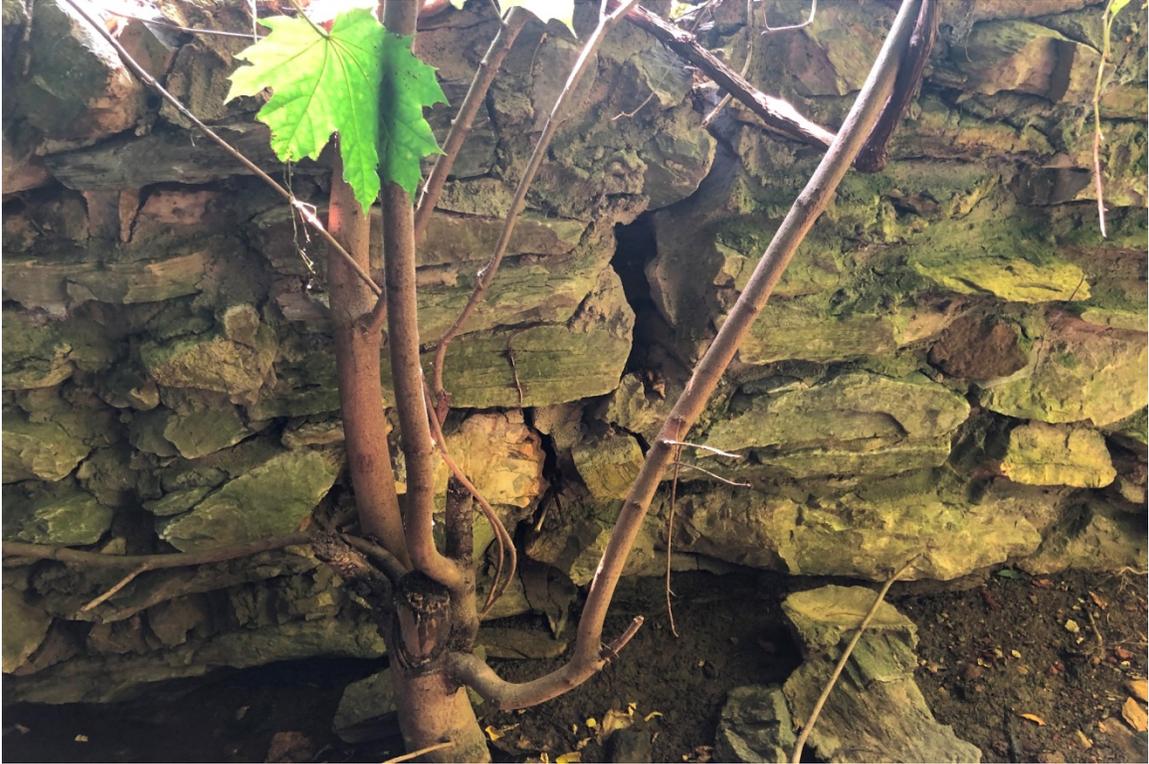
Failing stone wall

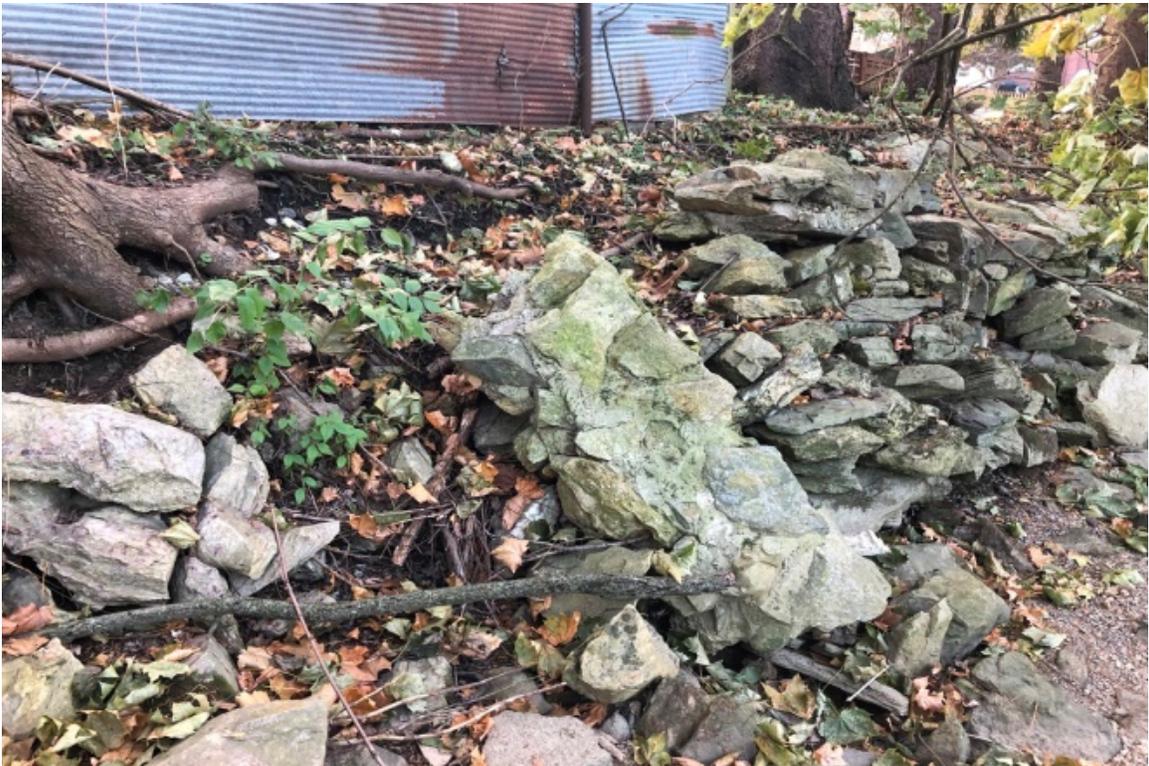
Rubble along left bank

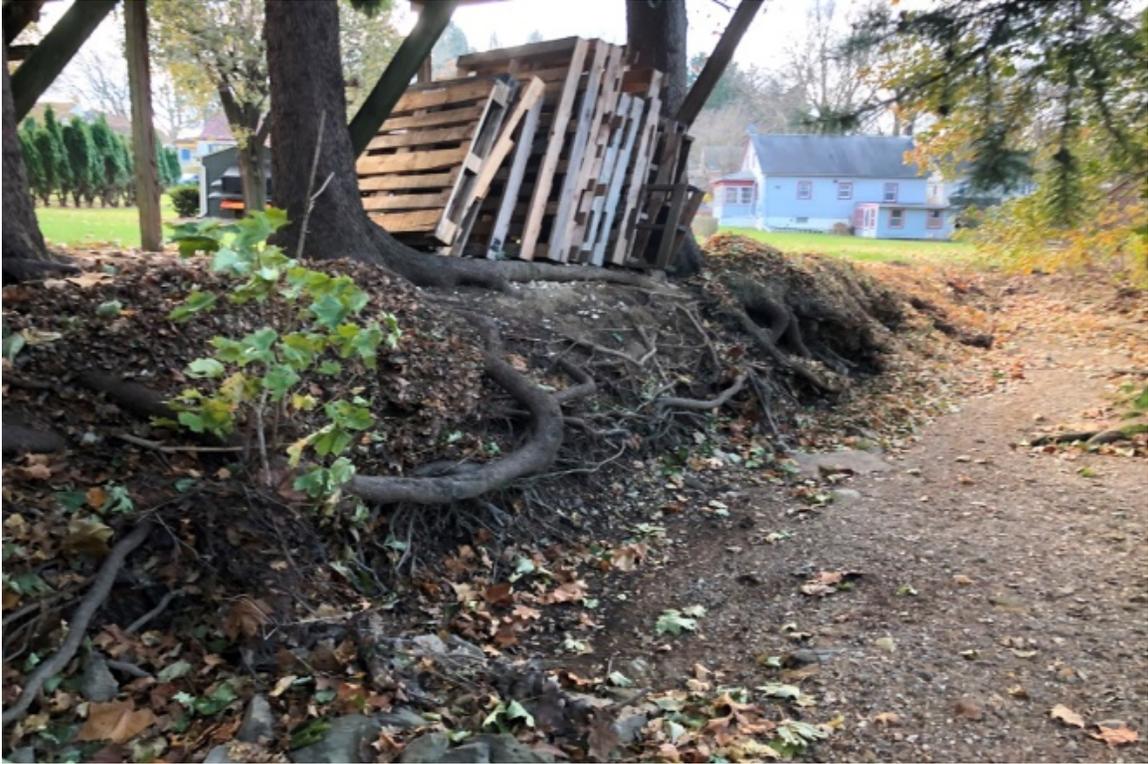
Bank erosion and undercut trees along left bank

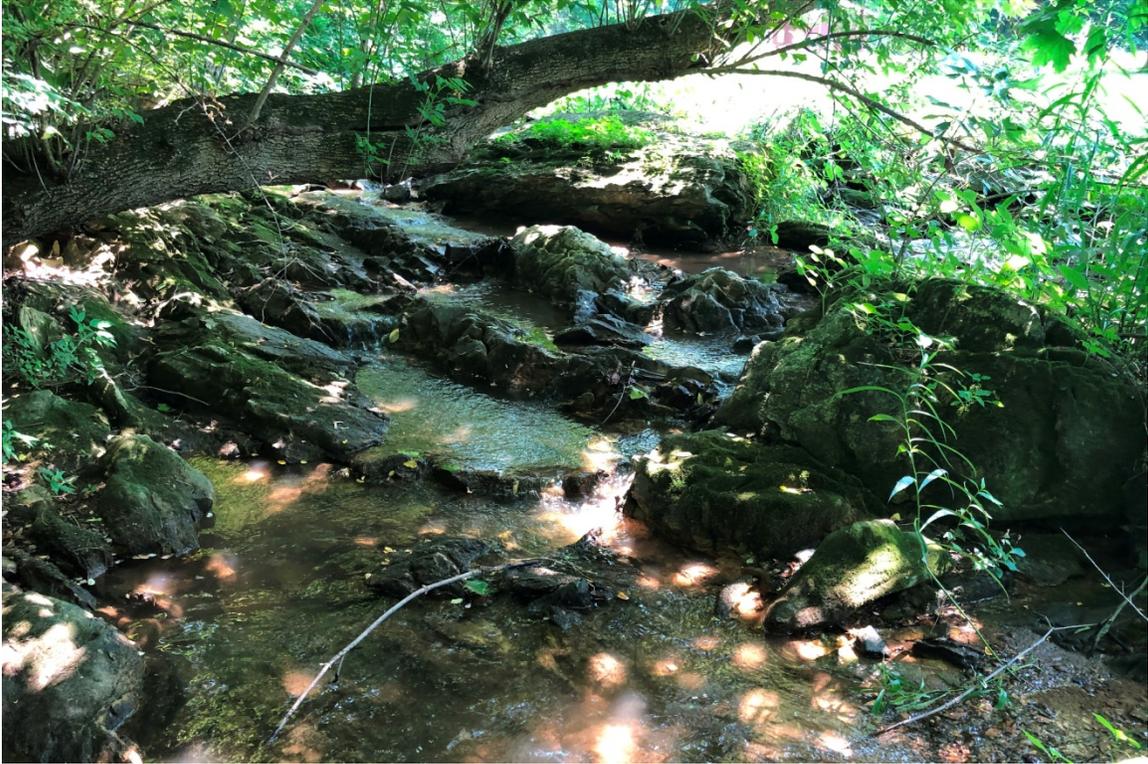
Bedrock bottom at upstream end of Reach 2

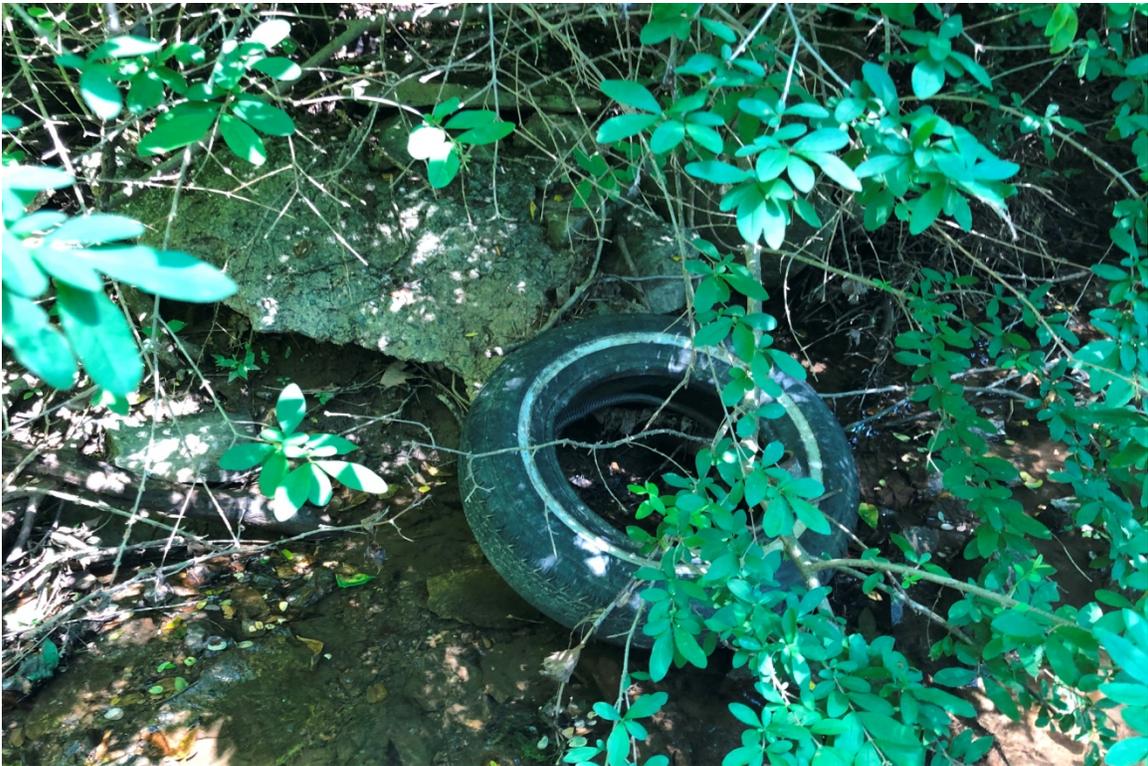
Broken concrete and tires along toe of right bank

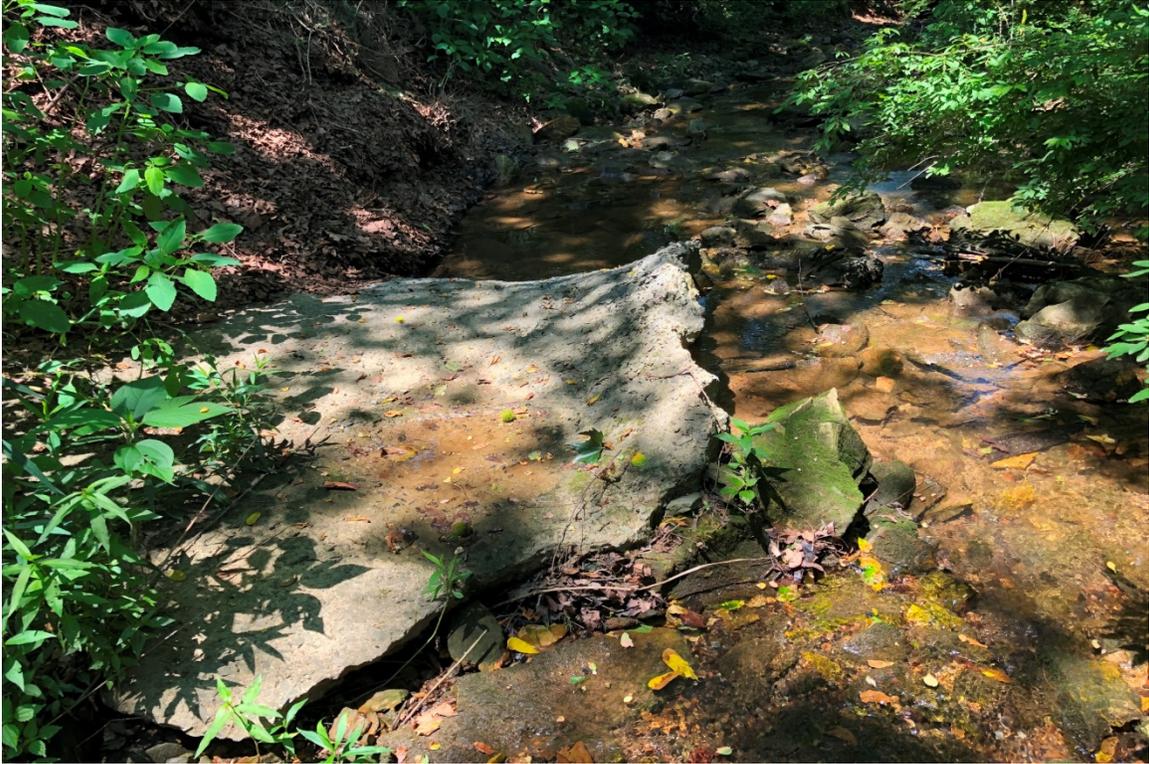
Broken concrete along toe of left bank

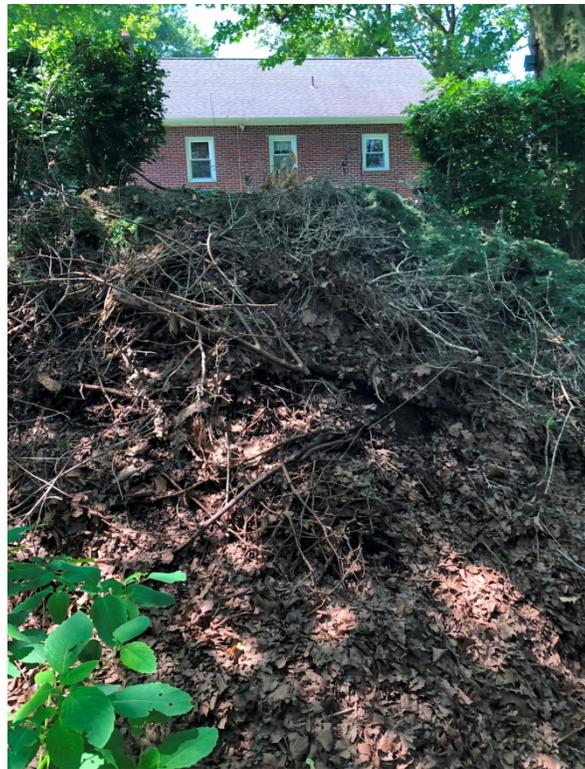
Yard waste placed along steep eroding left bank

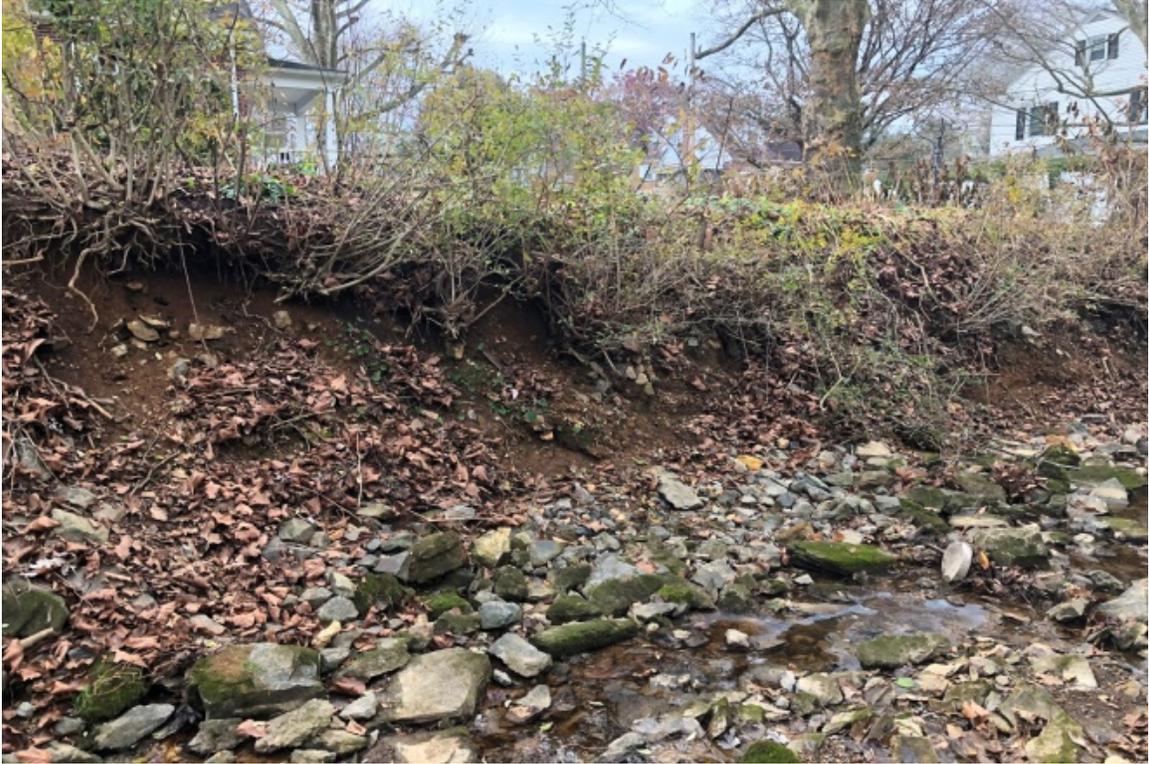
Eroding left bank with minimal woody vegetation

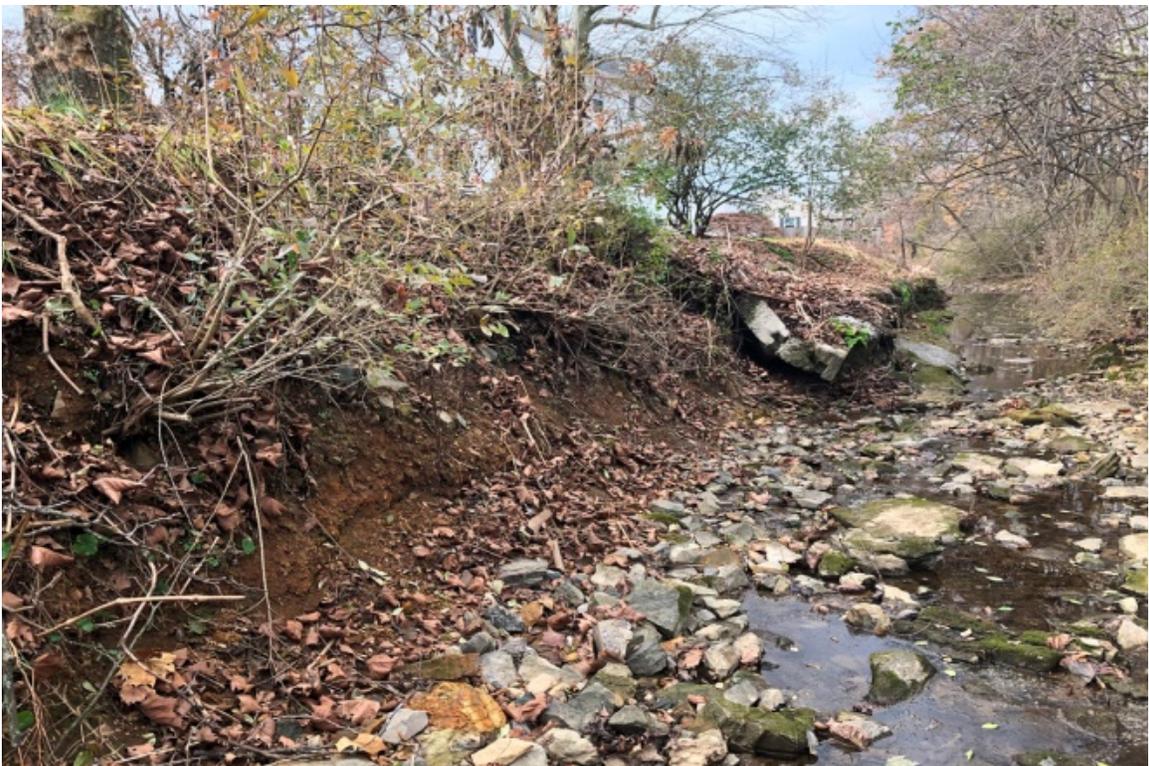
Bank erosion and failing concrete wall along left bank

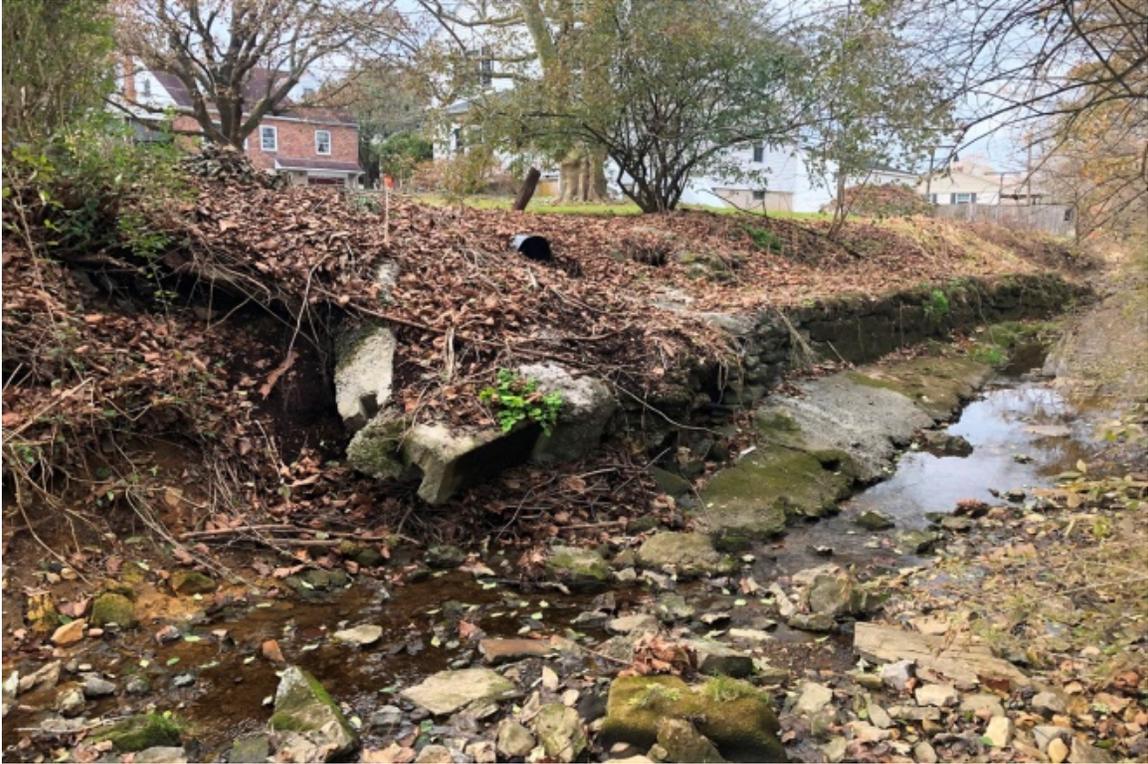
Failing concrete toe and stone wall along left bank

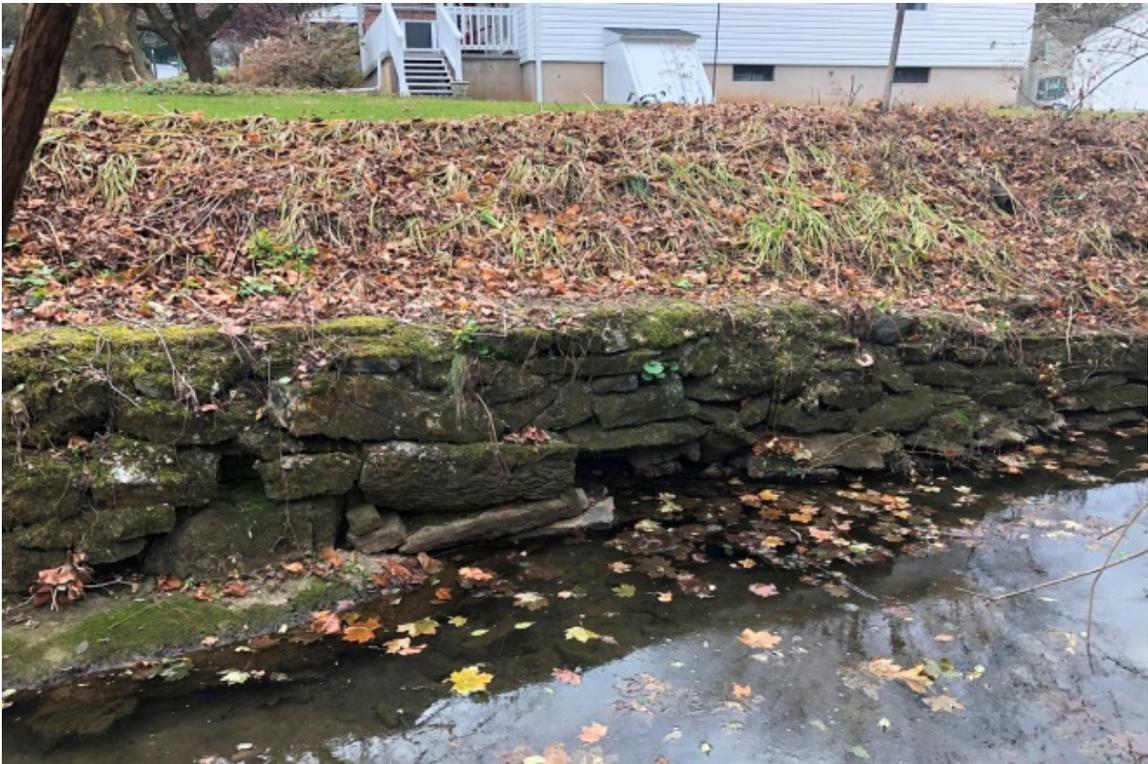
Failing stone wall along left bank

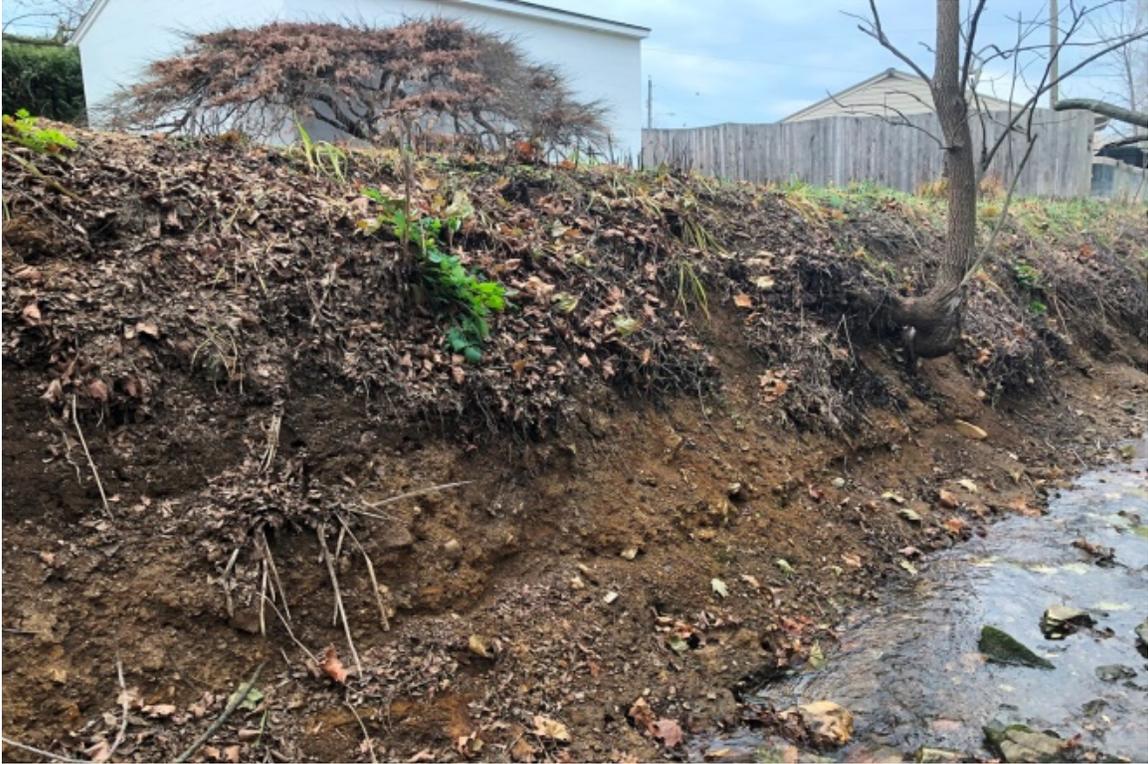
Steep eroding left bank with no woody vegetation

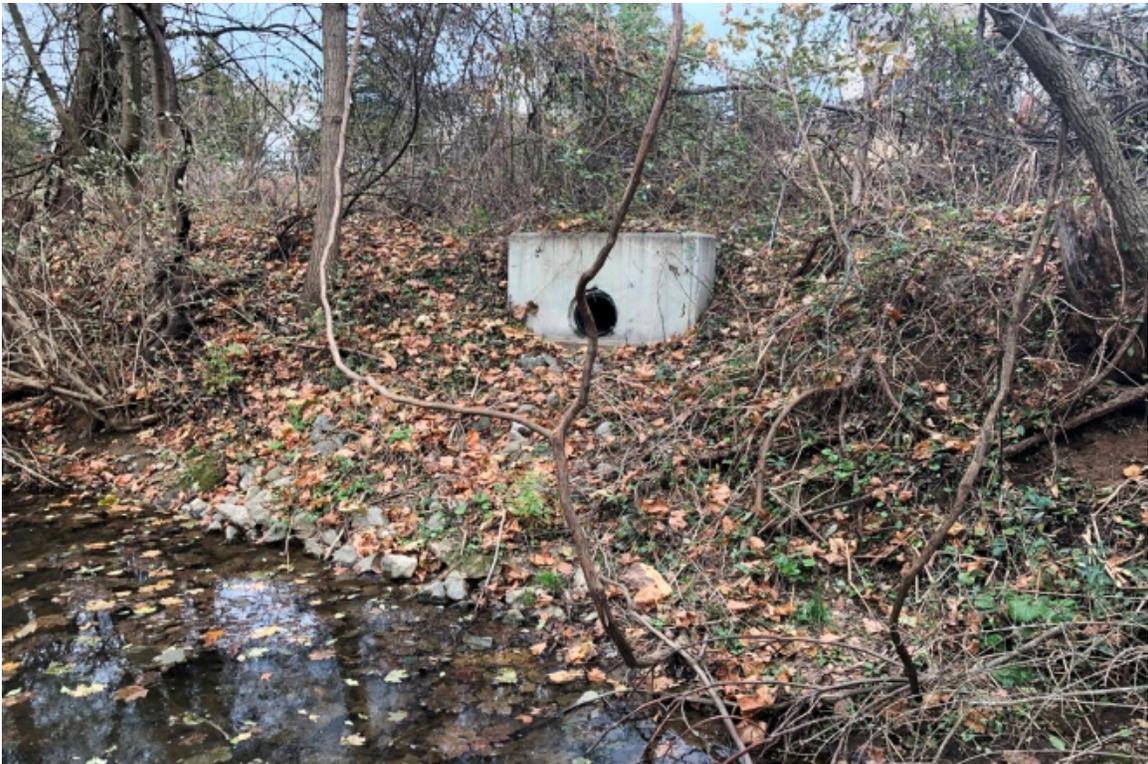
Outfall of stormwater management pond along right bank

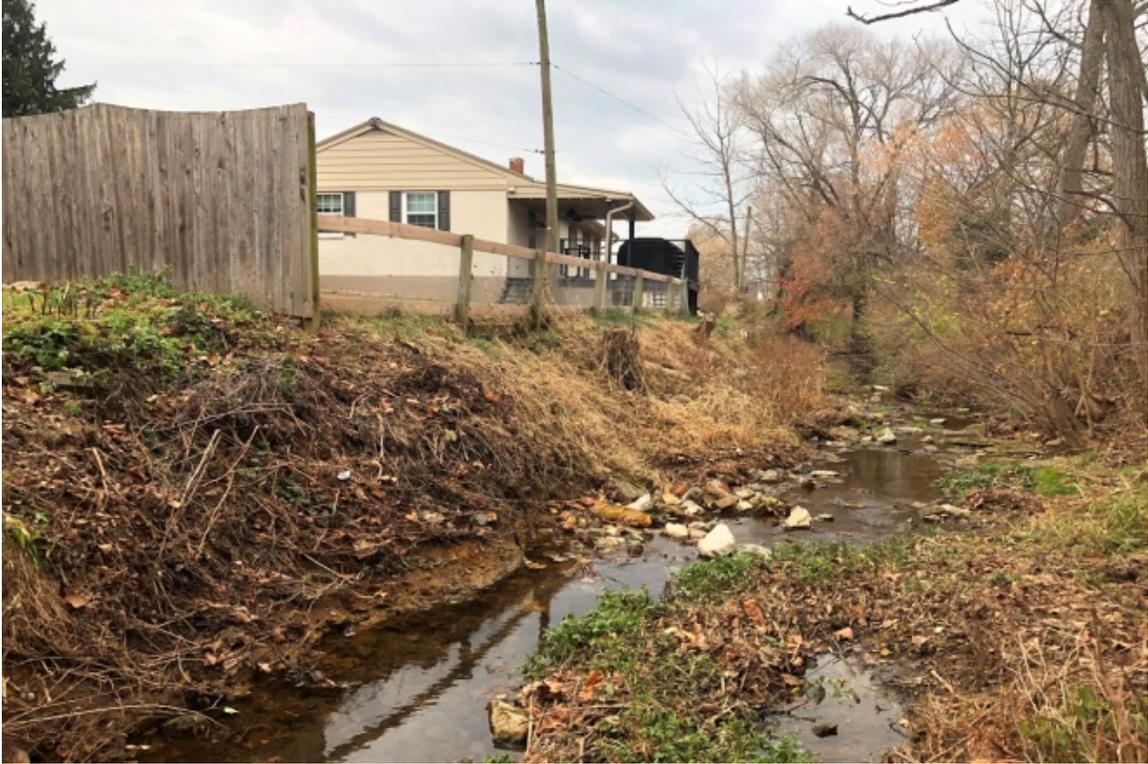
Bank at upstream end of Reach 3 with all vegetation removed and replaced with scattered loose rock

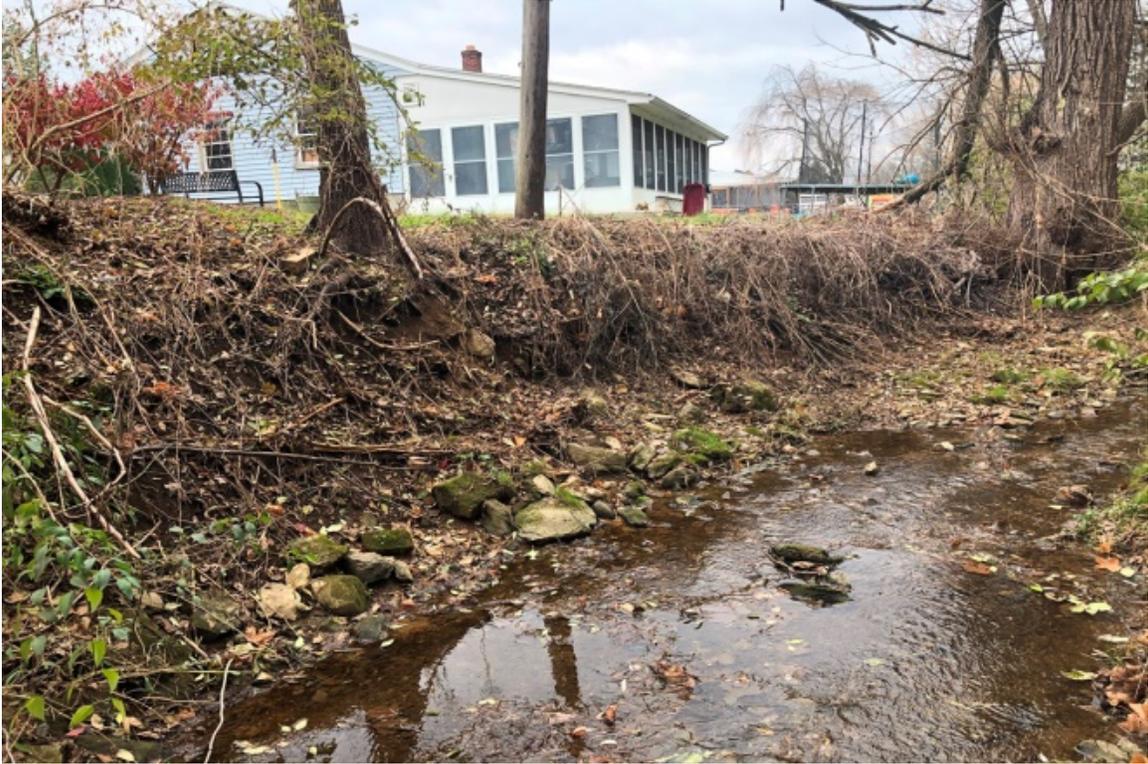
Erosion and undercut trees along left bank

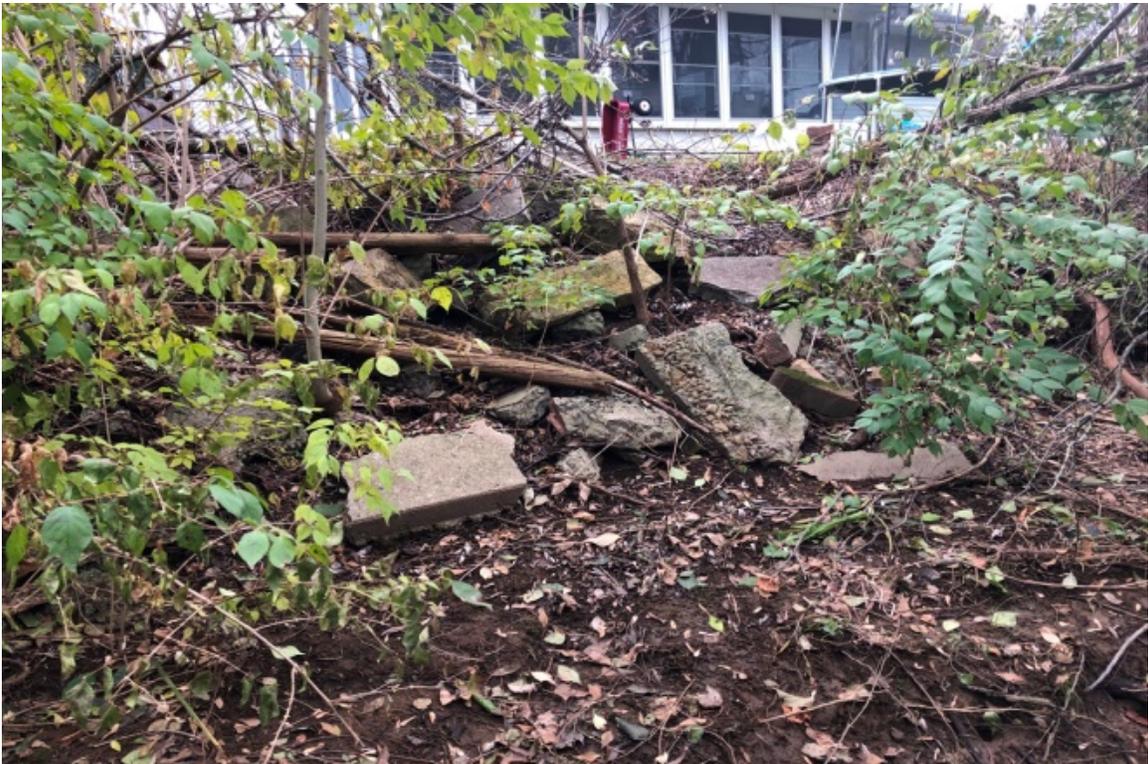
Failing concrete slabs and rock along left bank

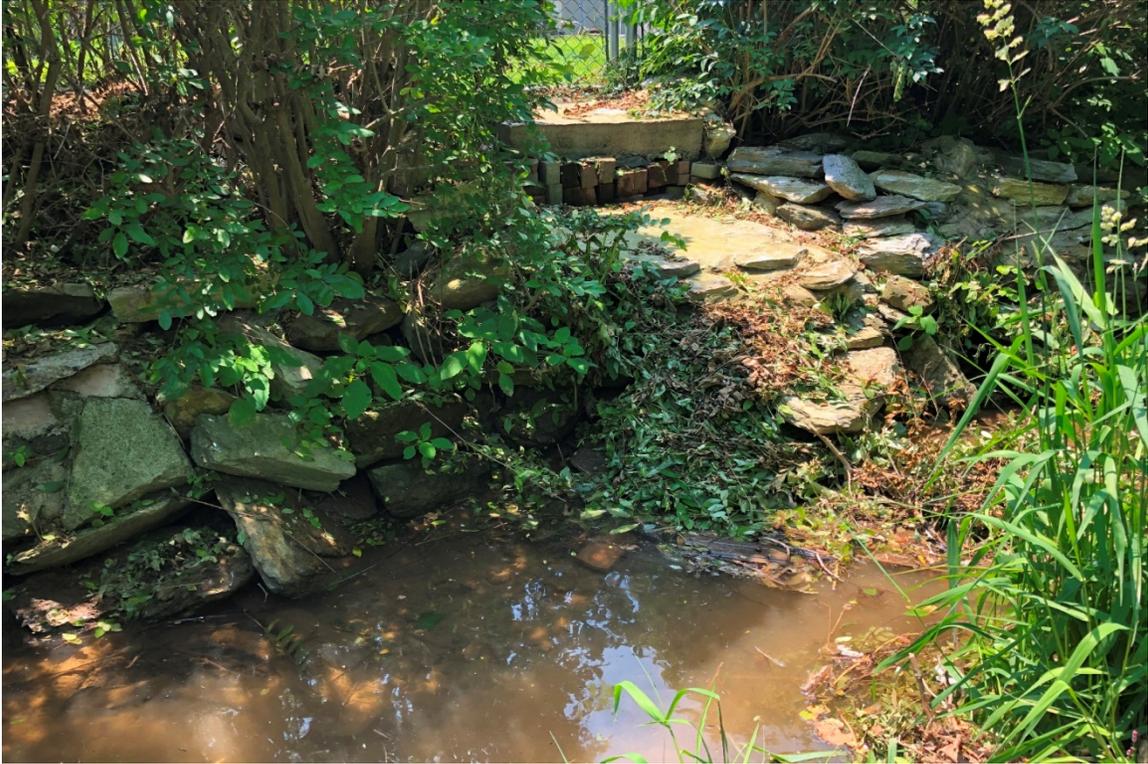
Rubble revetment along left bank
