**Snitz Creek 4 Stream Restoration and Stormwater Retrofit Project
Cornwall Borough, Lebanon County, Pennsylvania**

**Pennsylvania Department of Environmental Protection
Growing Greener Plus Grants**

December 2019

Snitz Creek #4 Stream Restoration and Stormwater Retrofit Project Detailed Project Description

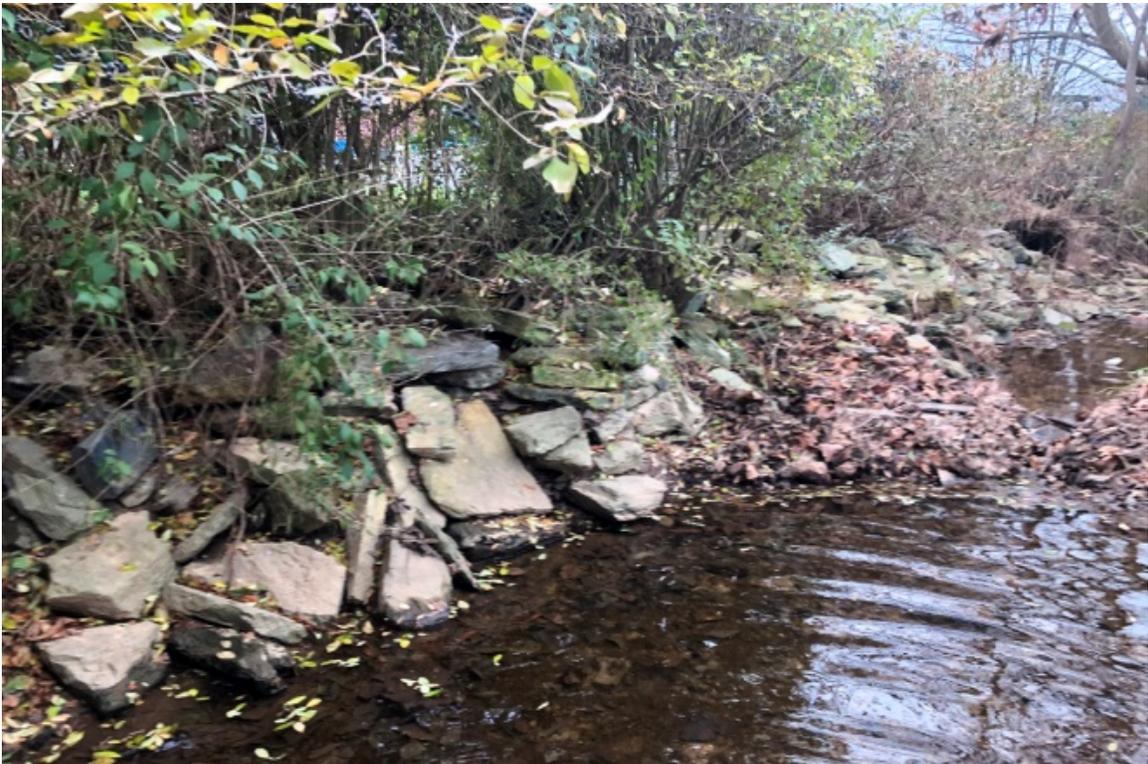
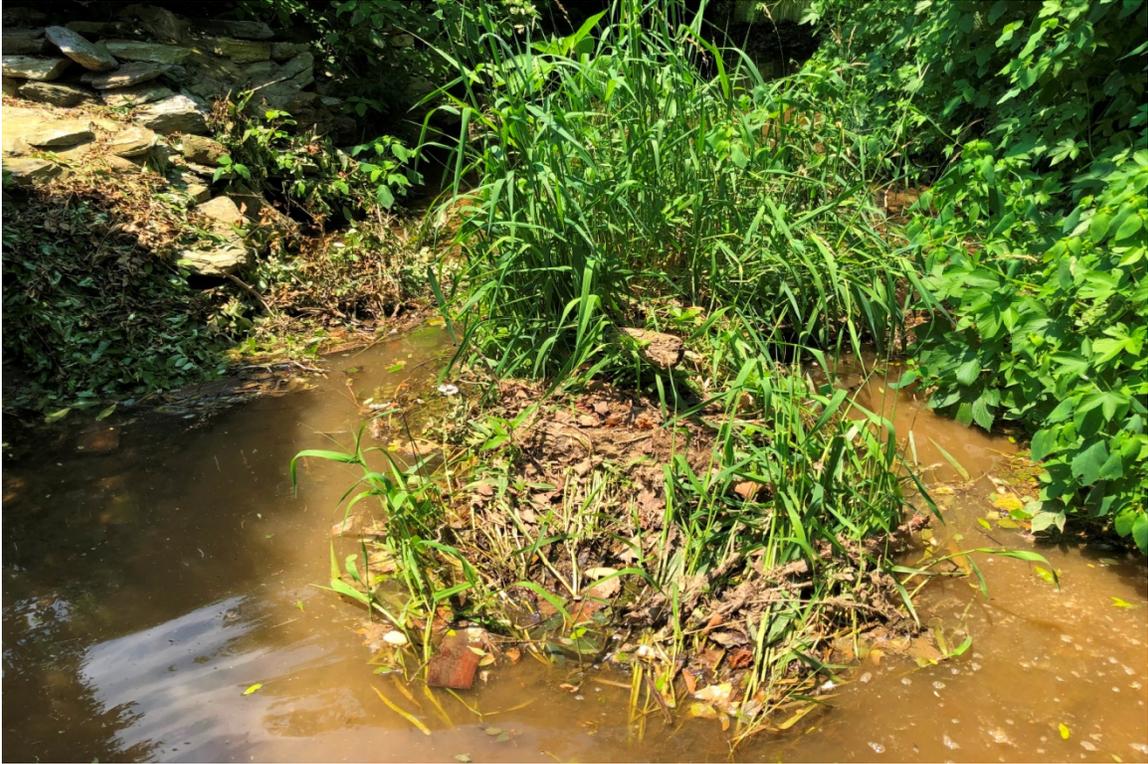
Mid-channel bar, summer (photo above), fall (photo below)

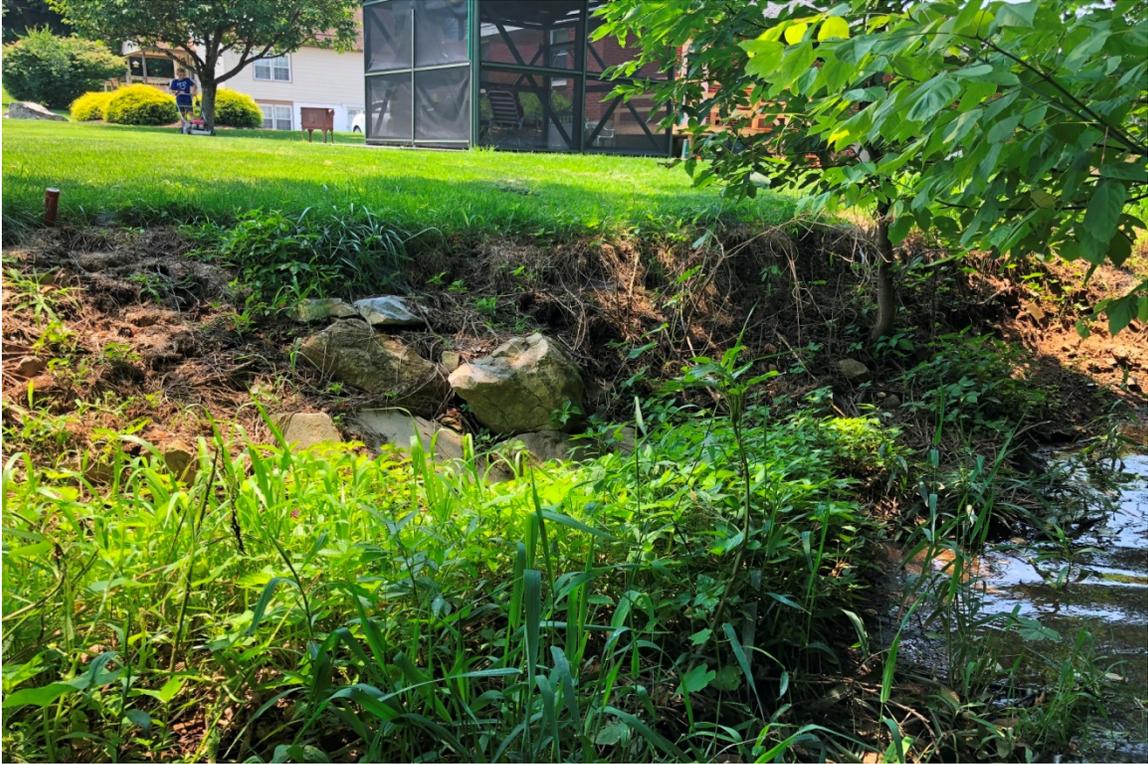
Eroding left bank with some rubble revetment

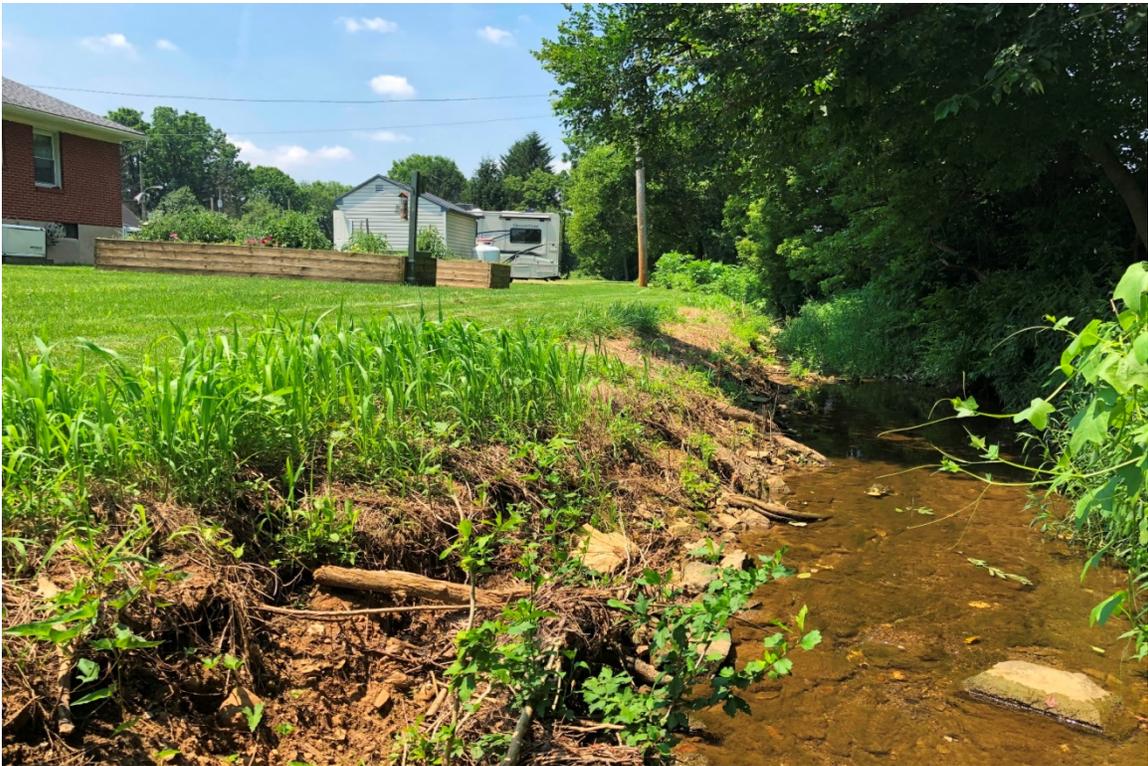
Erosion along toe of left bank where all vegetation has been removed by landowner

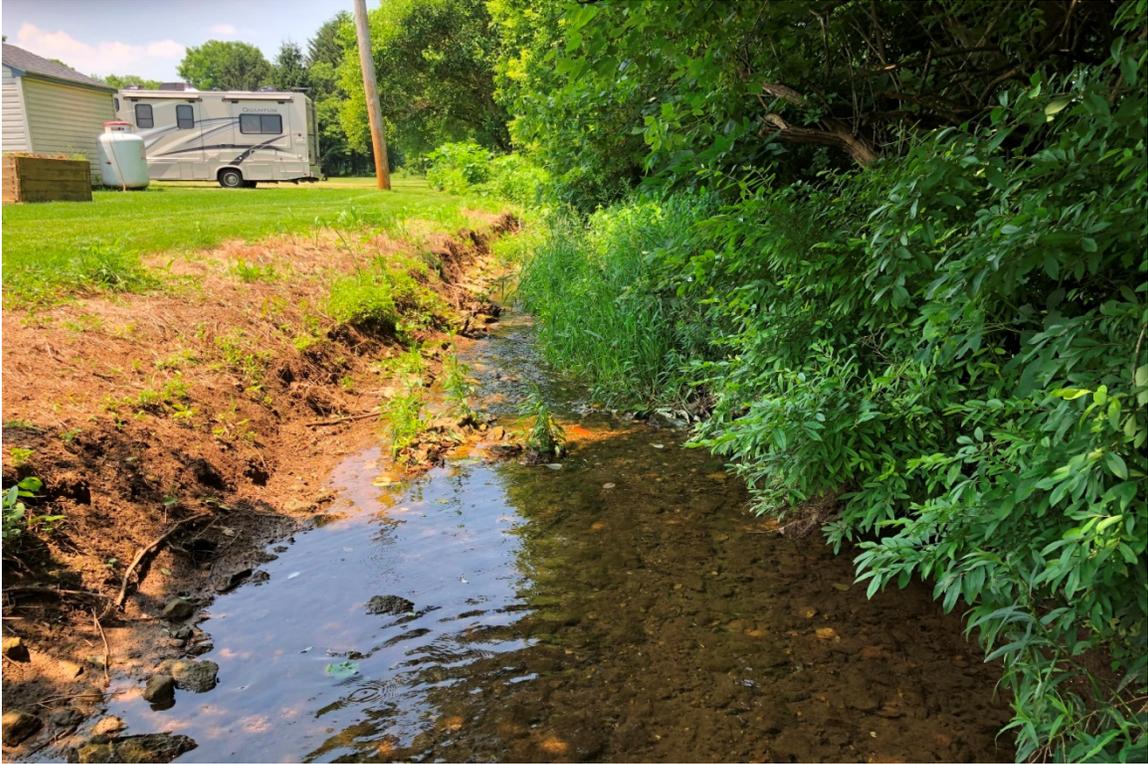
Erosion along left bank where all vegetation has been removed by landowner

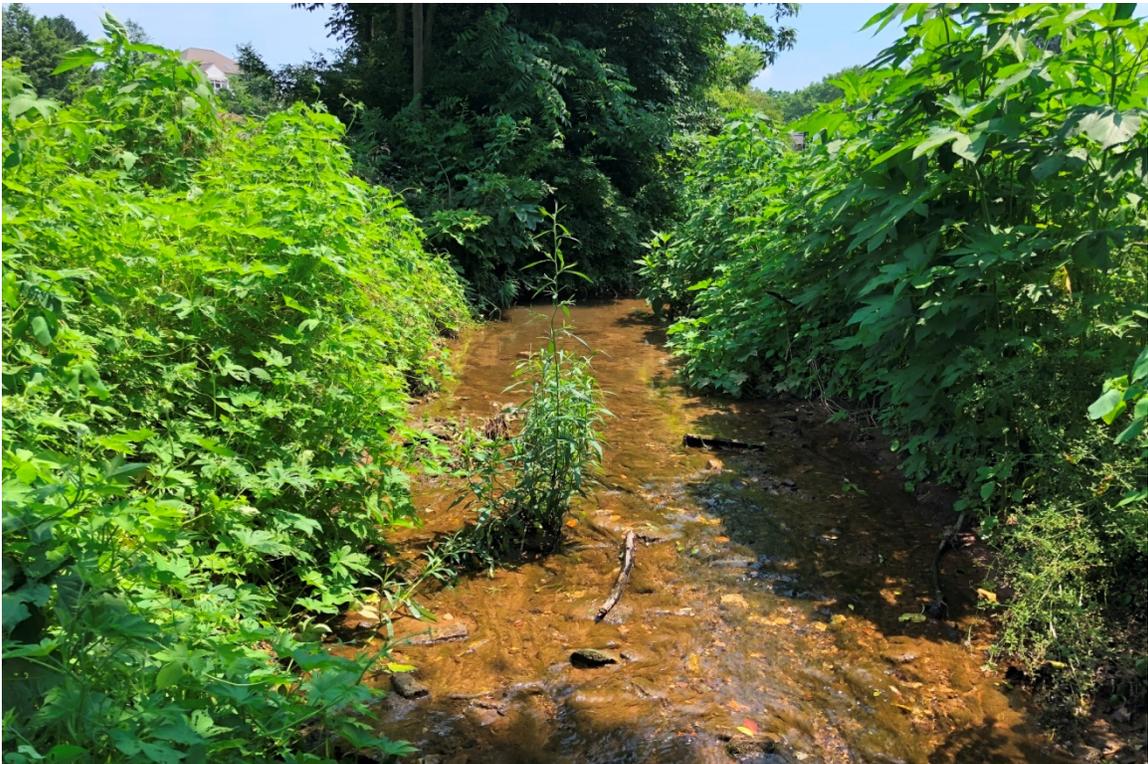
Streambanks overgrown with exotic and invasive weeds and vines at upstream end of Reach 4

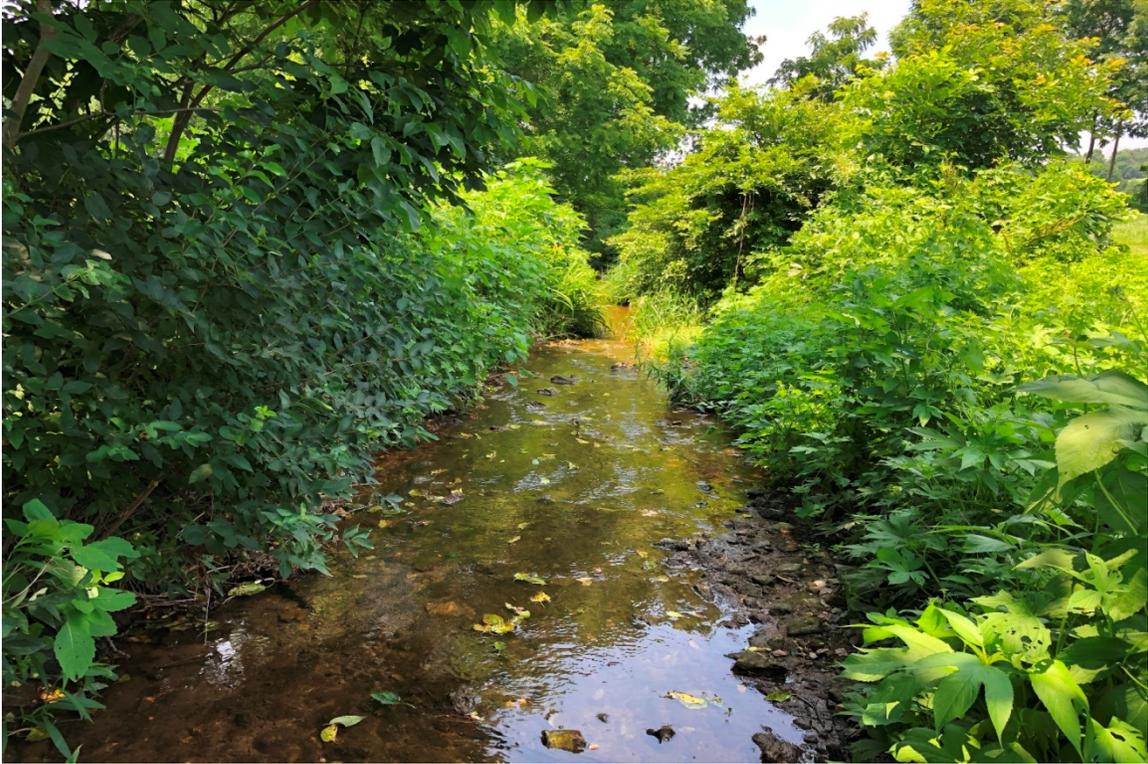
Overwide section

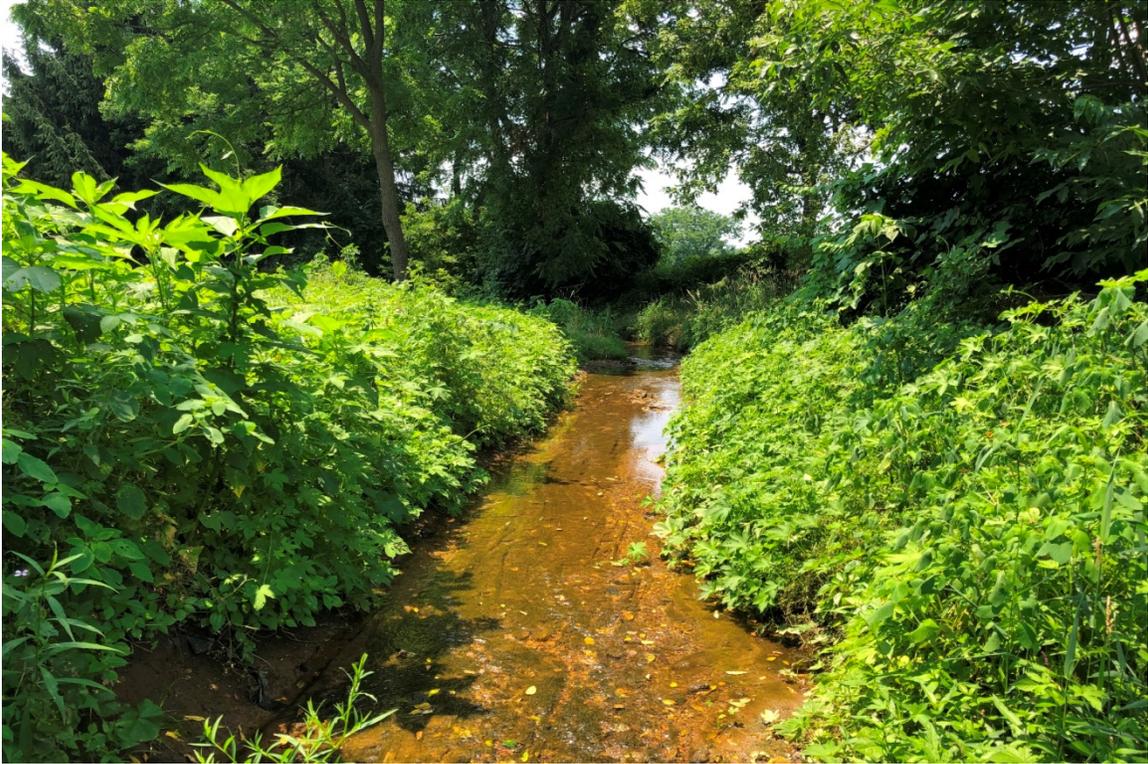
Streambanks overgrown with exotic and invasive weeds and vines

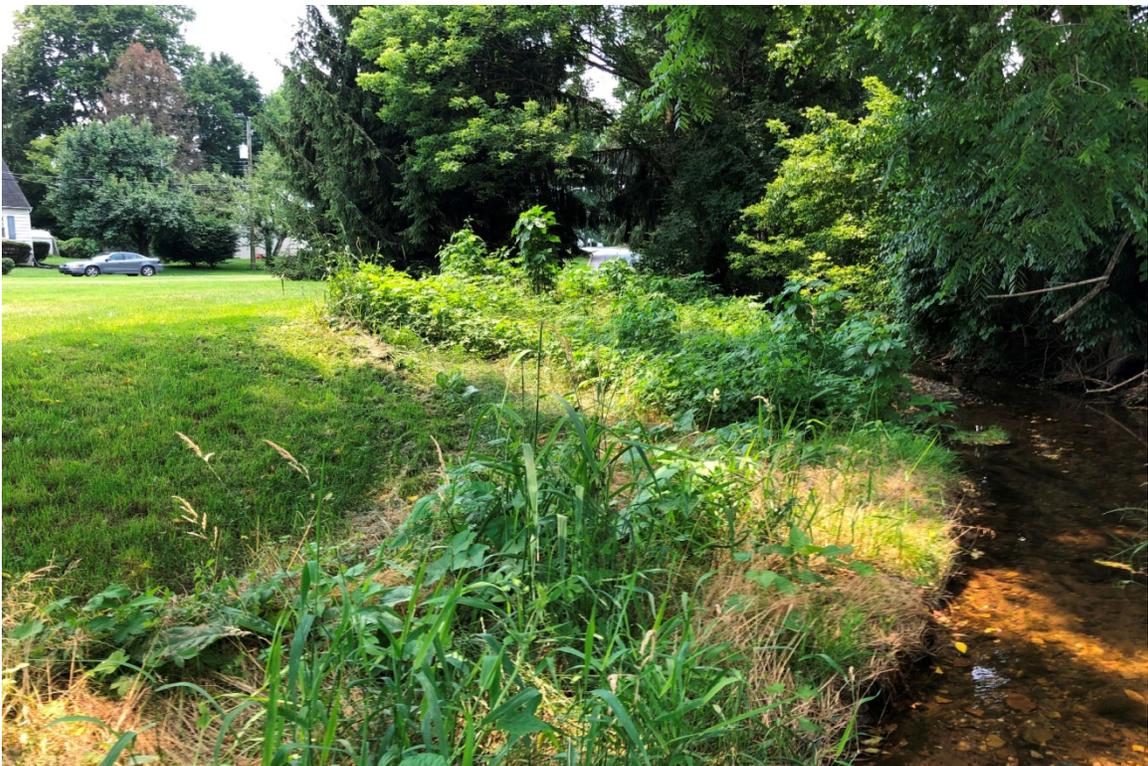
Low terrace with bankfull bench along inside of bend

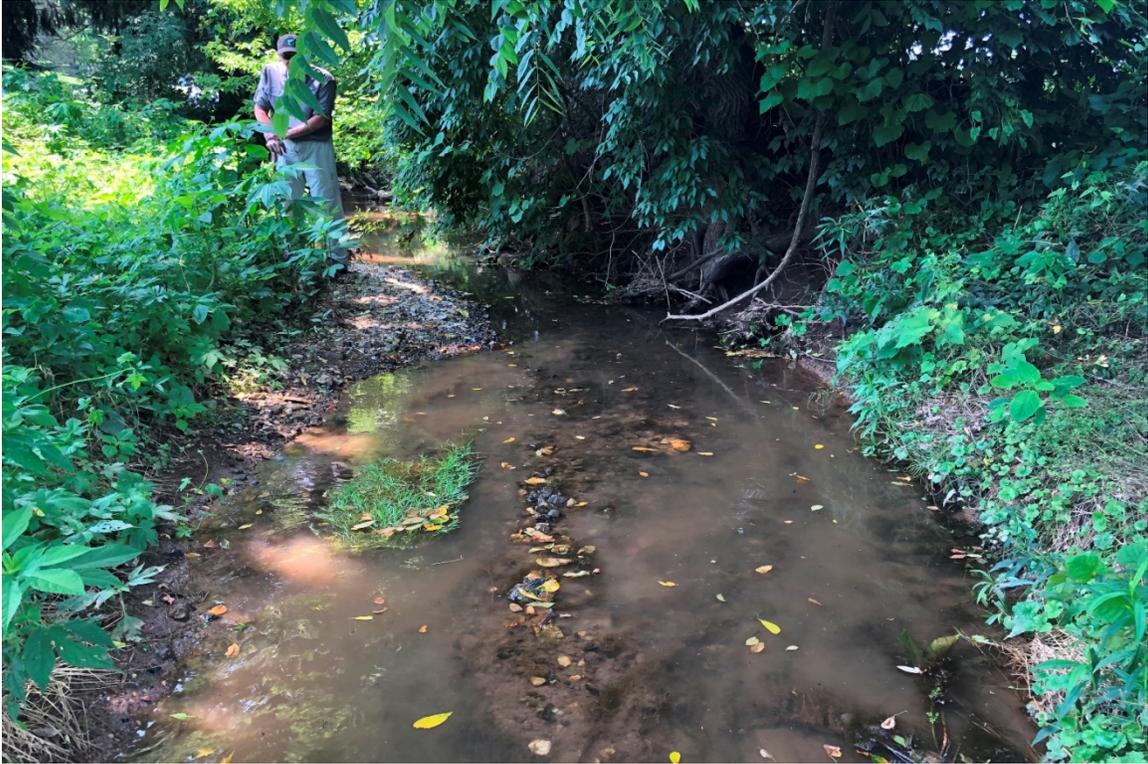
Overwide section with lateral bar and developing mid-channel bar

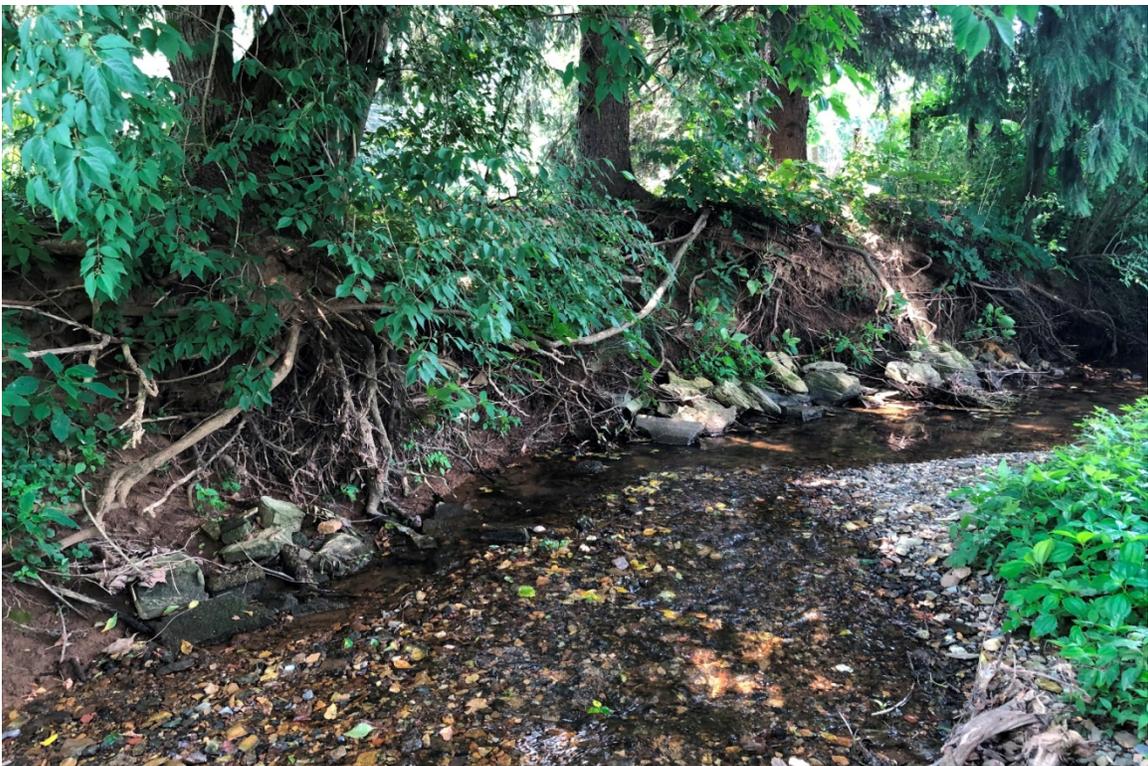
Erosion and undercut trees along left bank downstream end of Reach 4

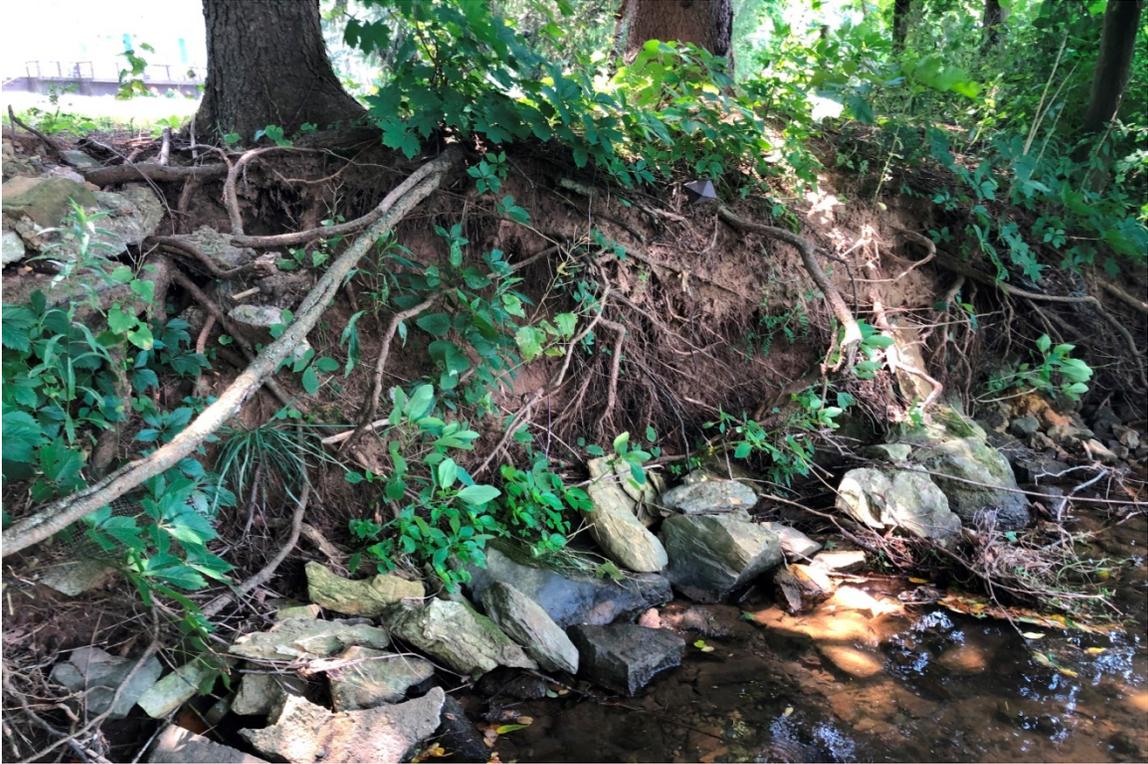
Erosion and undercut trees along left bank downstream end of Reach 4

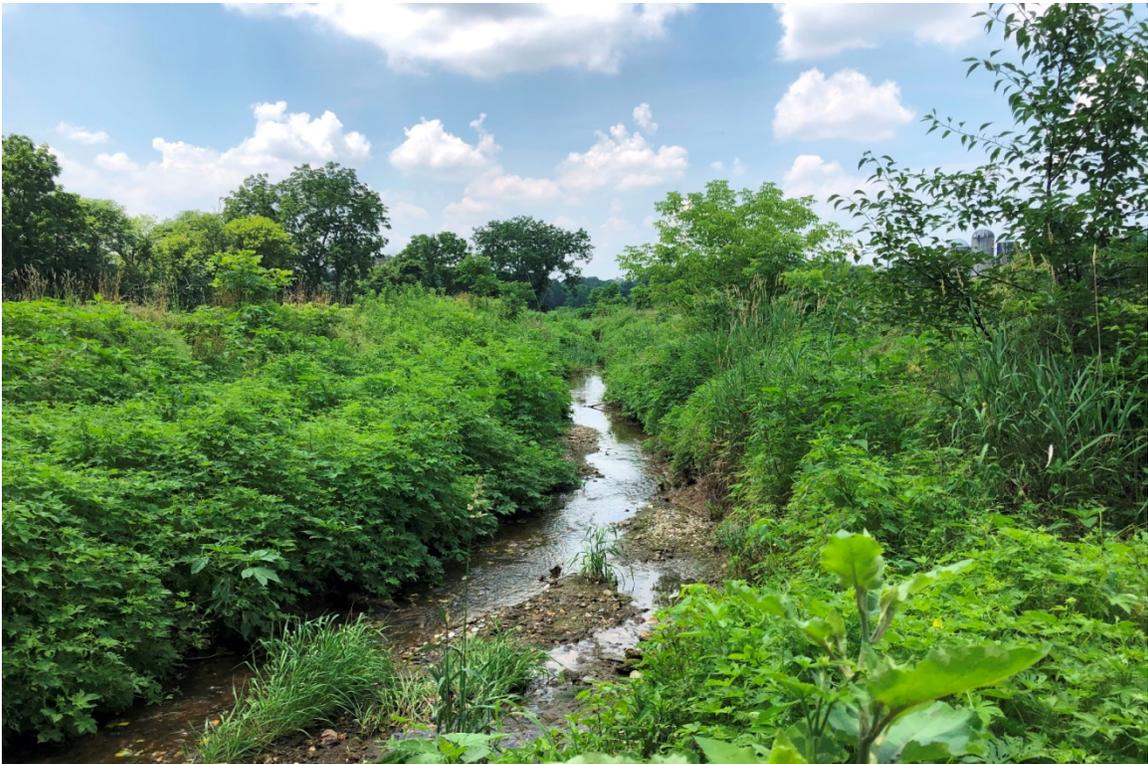
Lateral and mid-channel bars along upstream end of Reach 5

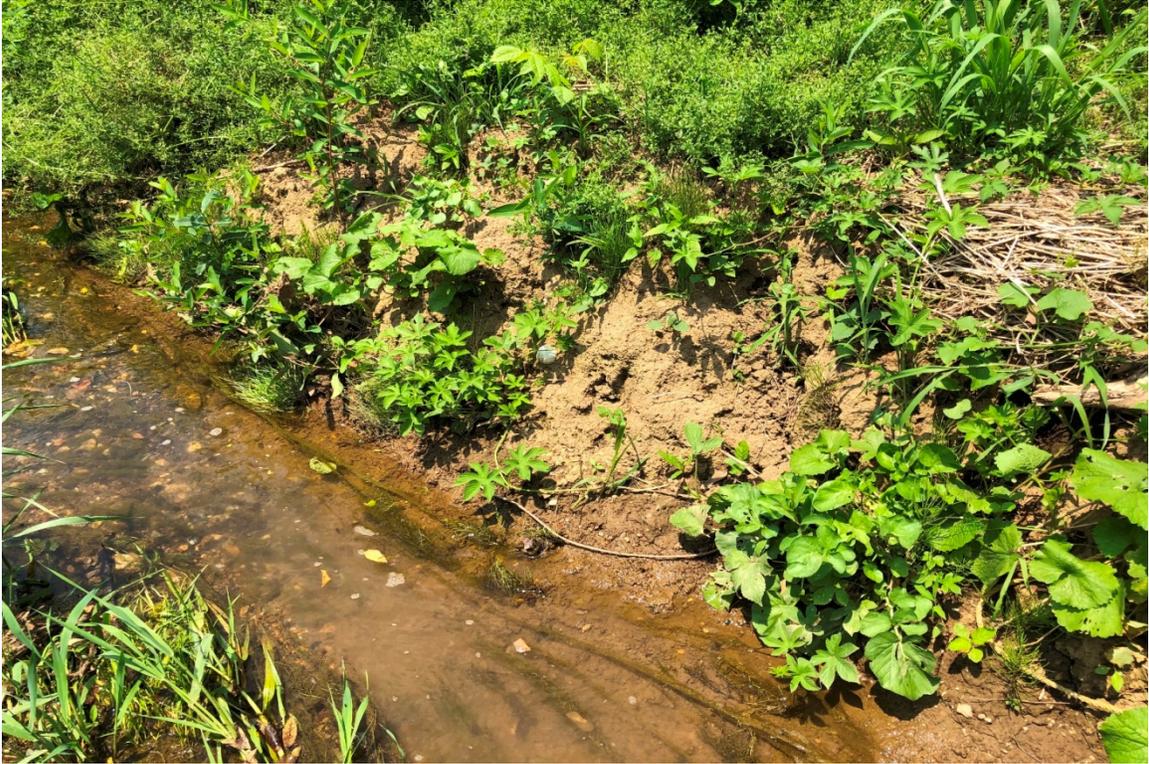
Erosion along right bank

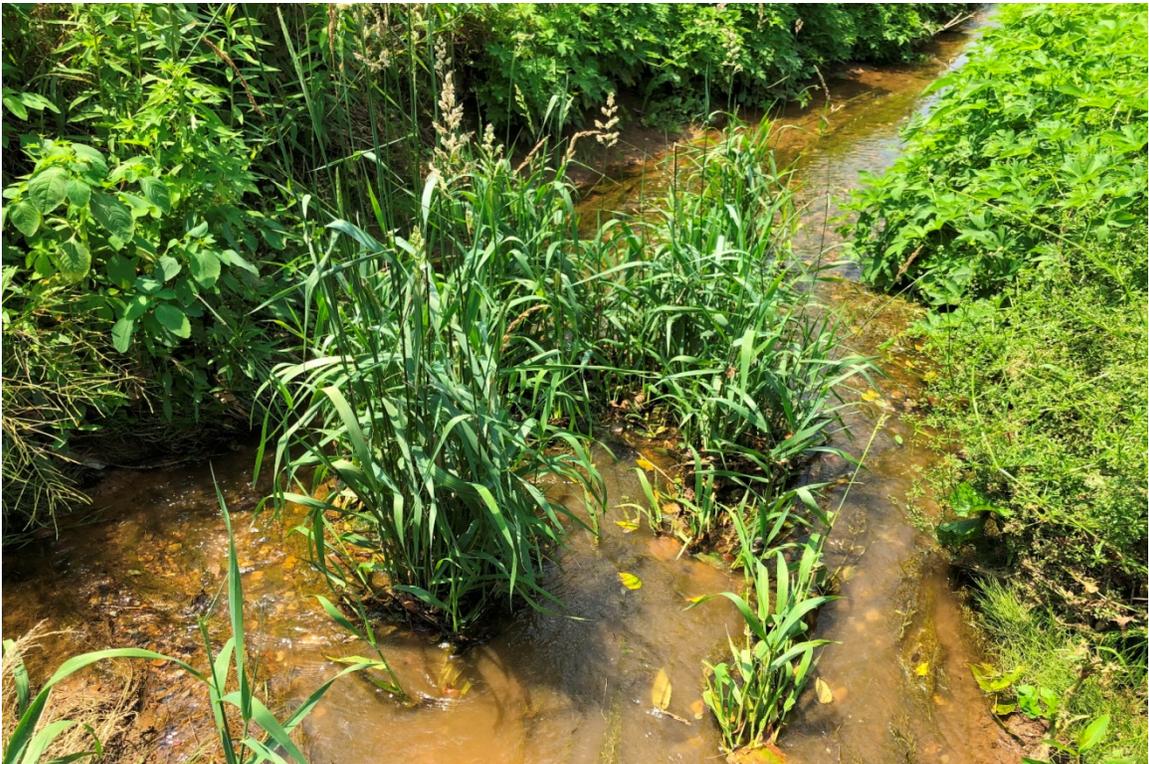
Vegetated mid-channel bar

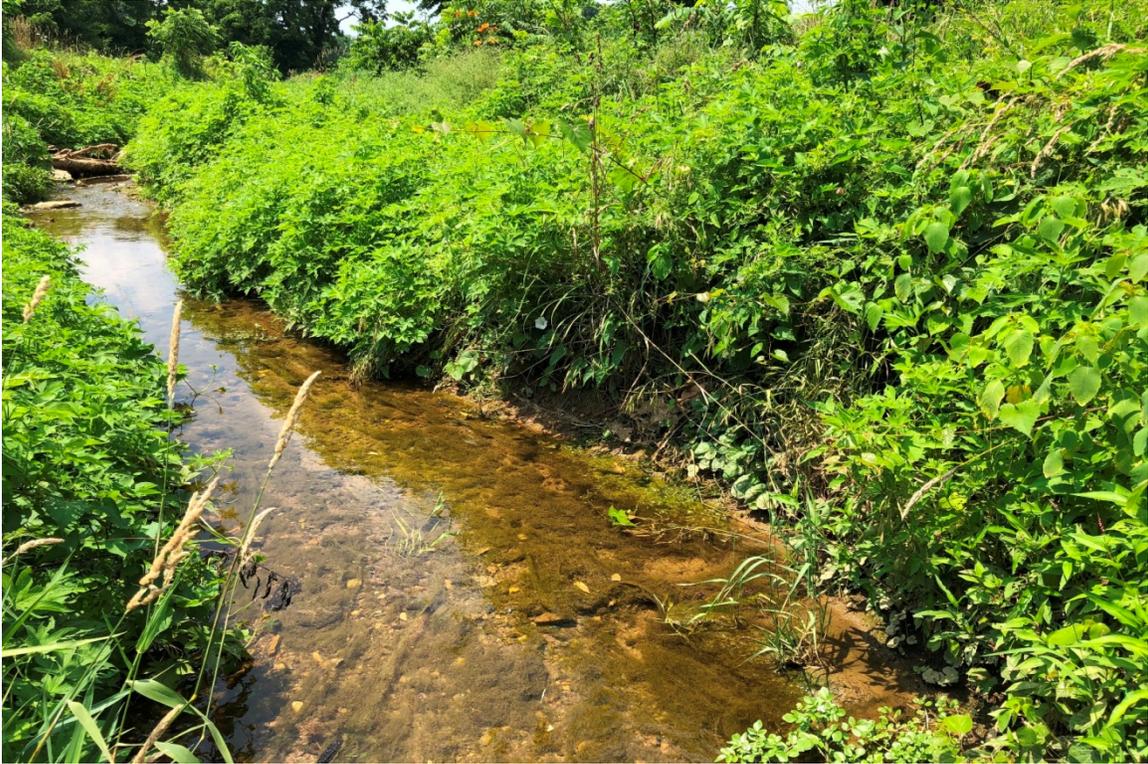
Erosion along right bank

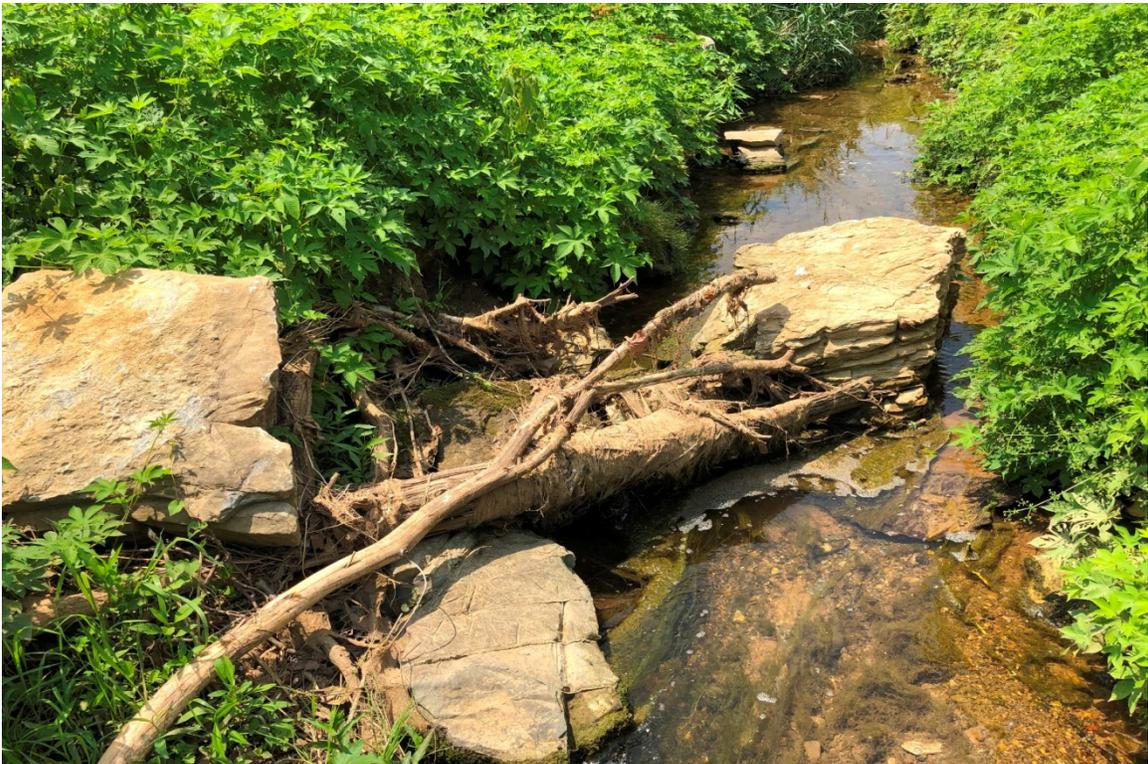
Remnants of landowners attempt to stabilize eroding bank

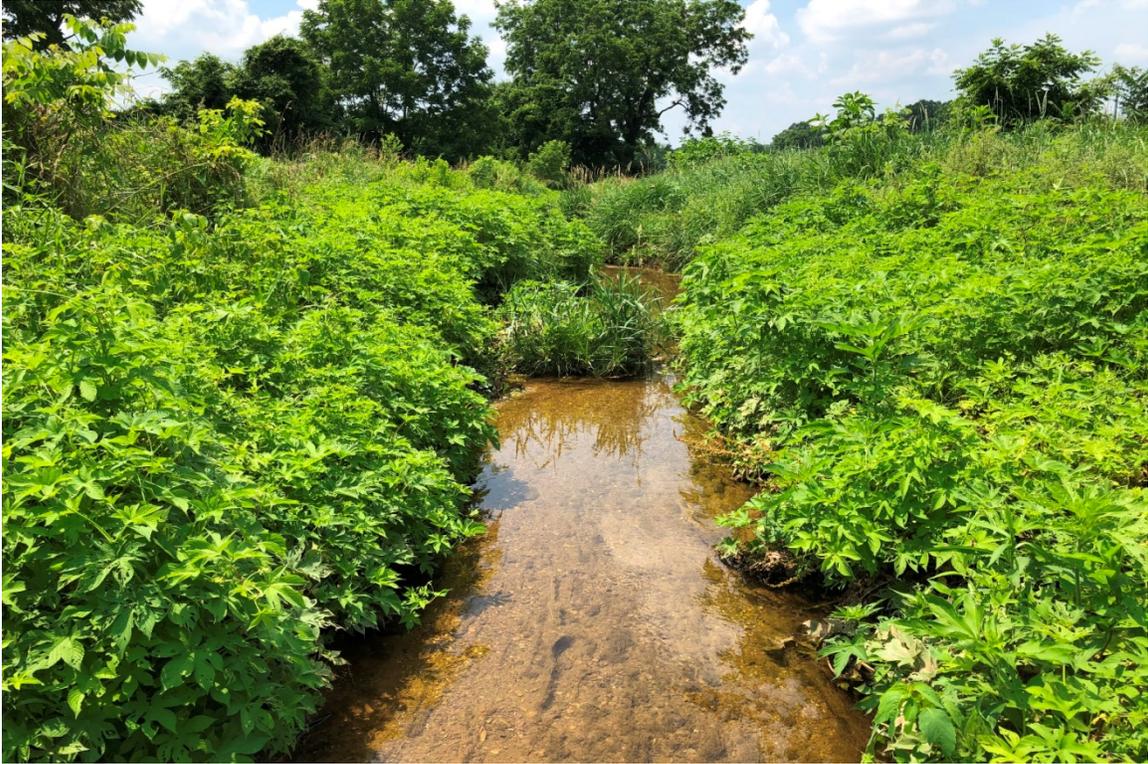
Streambanks over grown with exotic and invasive weeds and vines throughout entire reach

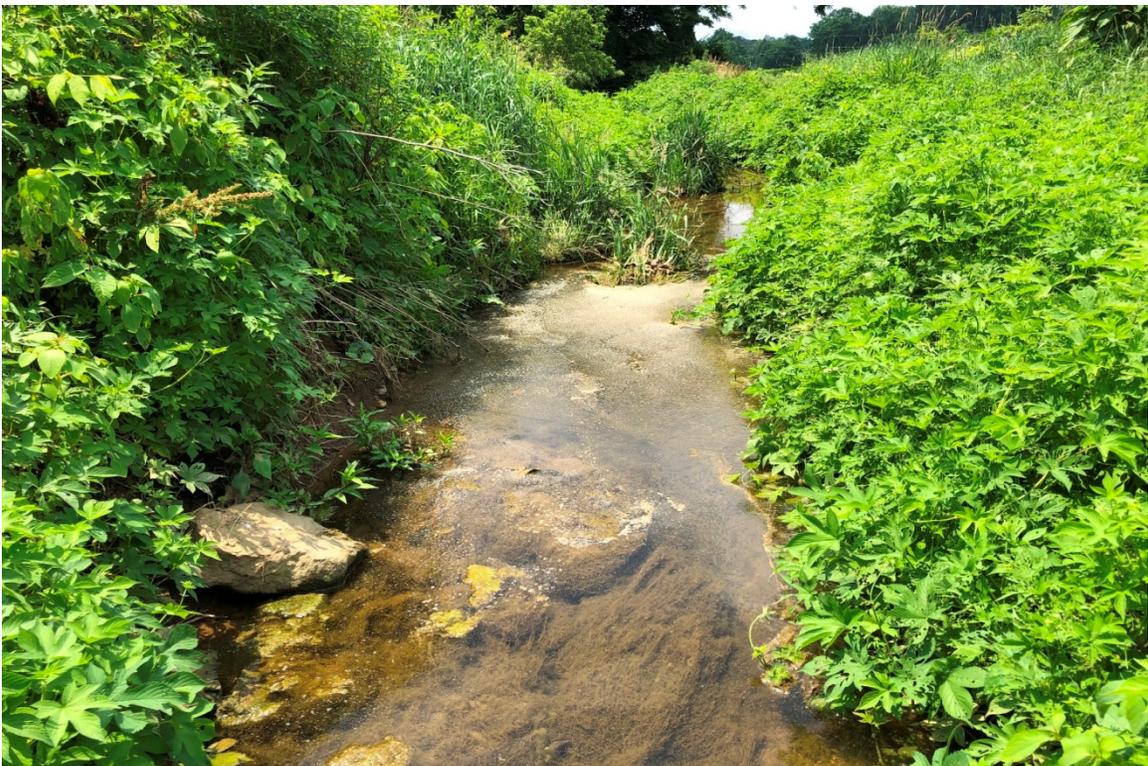
Thick mats of filamentous algae and floating scum

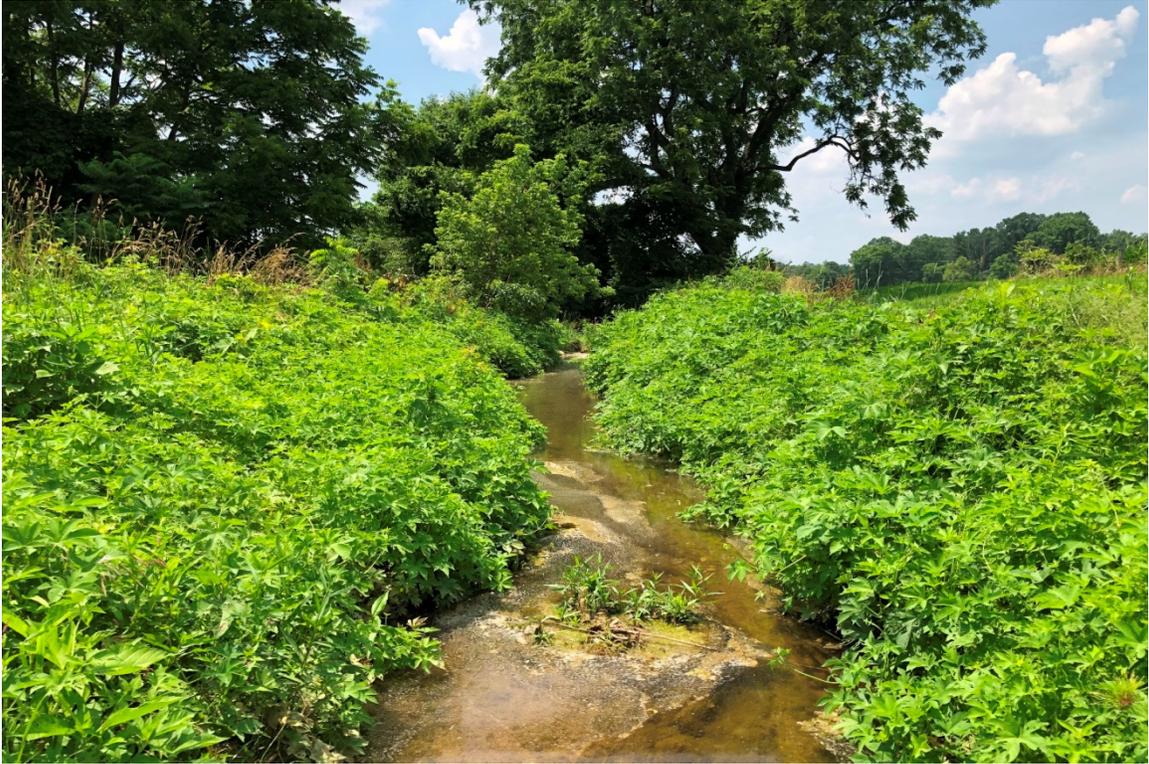
Thick mats of filamentous algae and floating scum

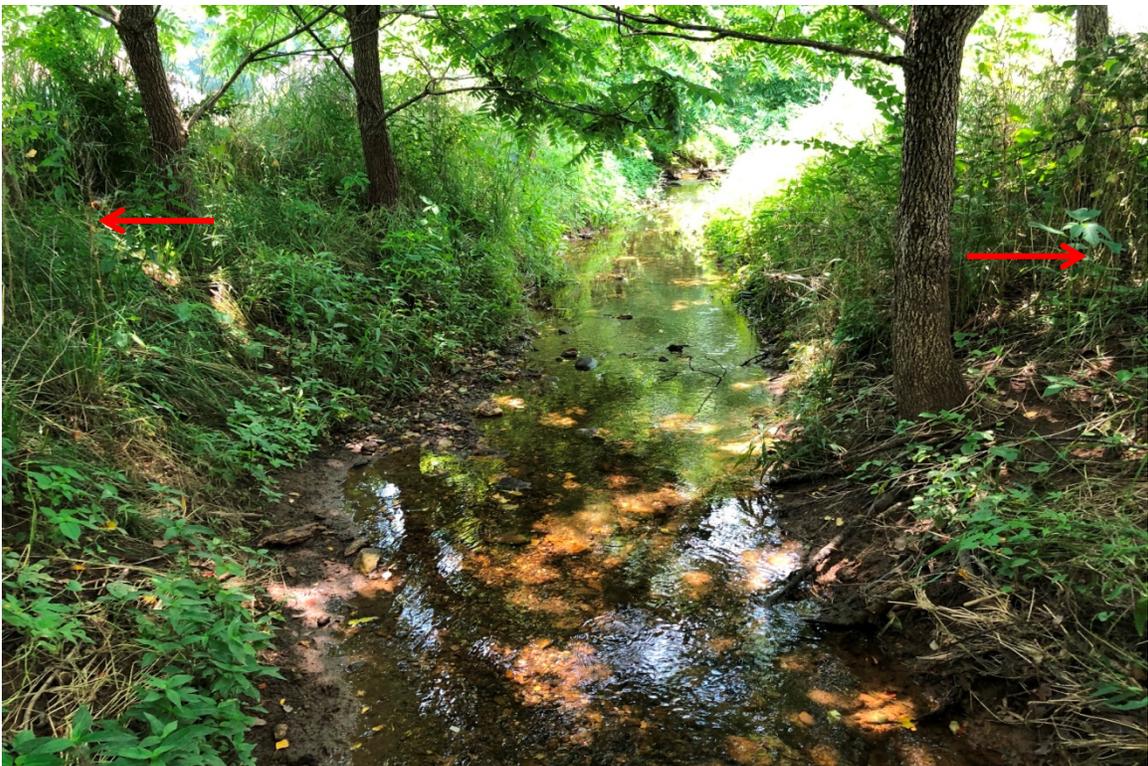
Confined upper section of Reach 6 (top of banks red arrows)

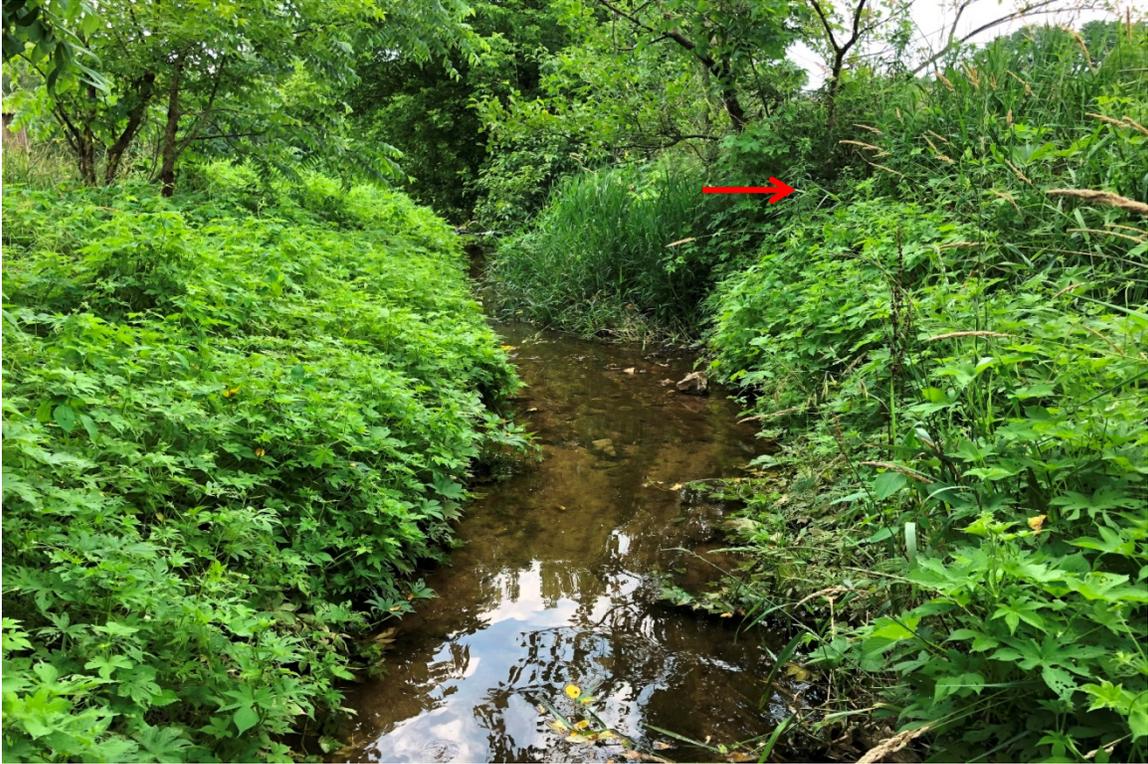
Steep, vertical right bank (top of bank red arrow)

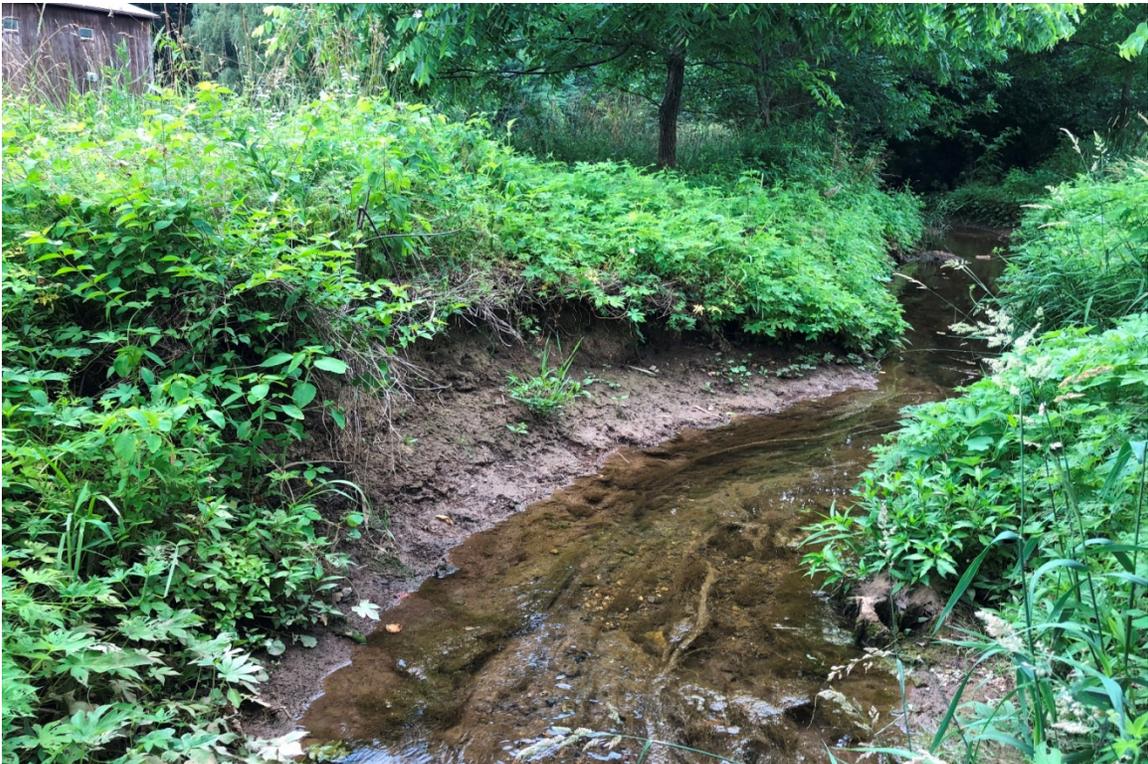
Erosion along left bank

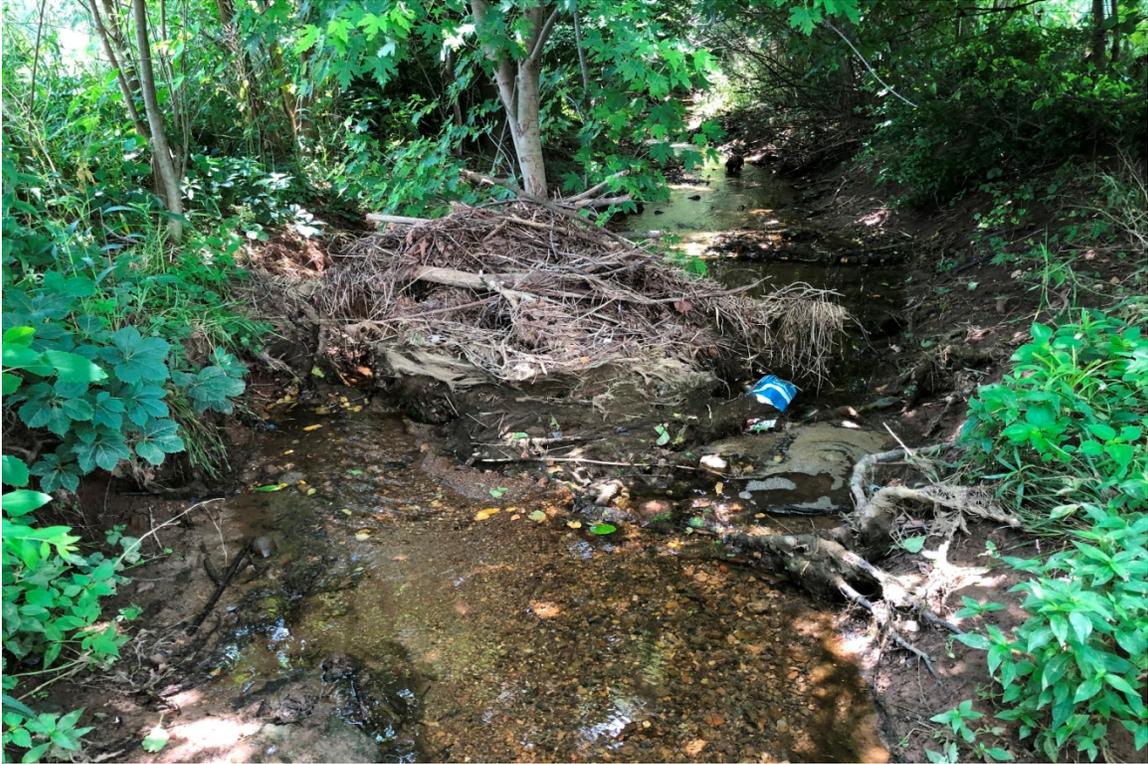
Debris jam and erosion along both banks

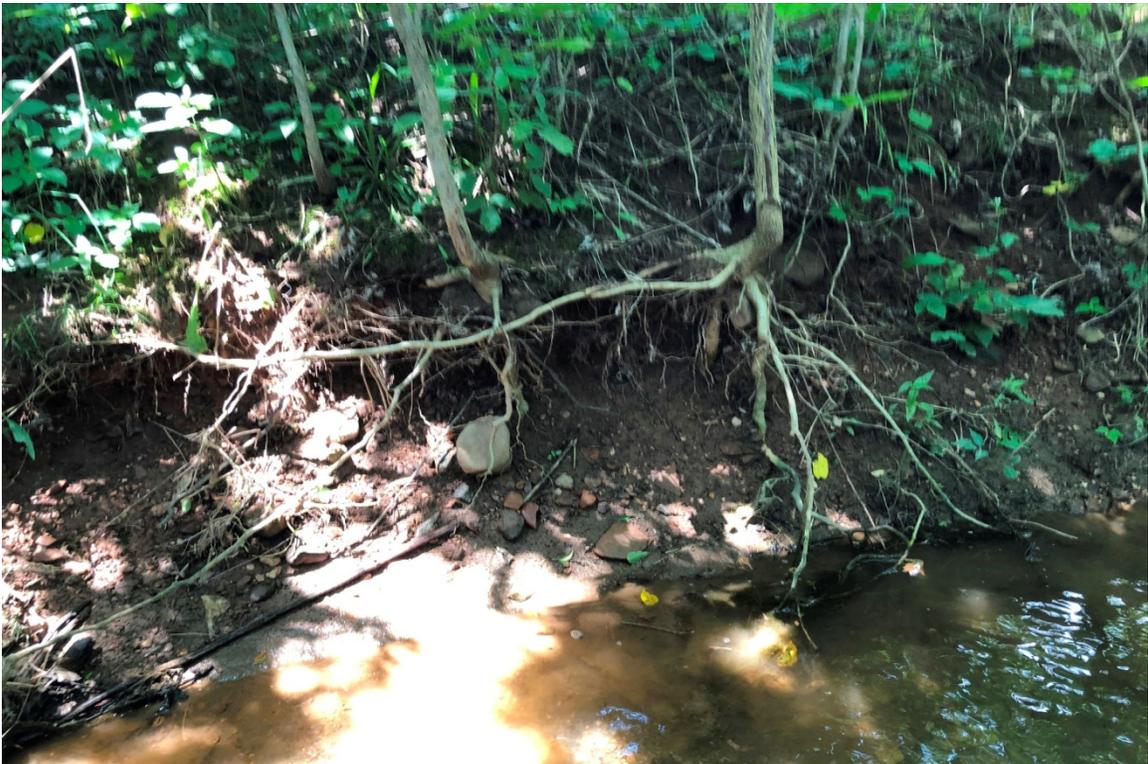
Erosion and undercut trees along right bank

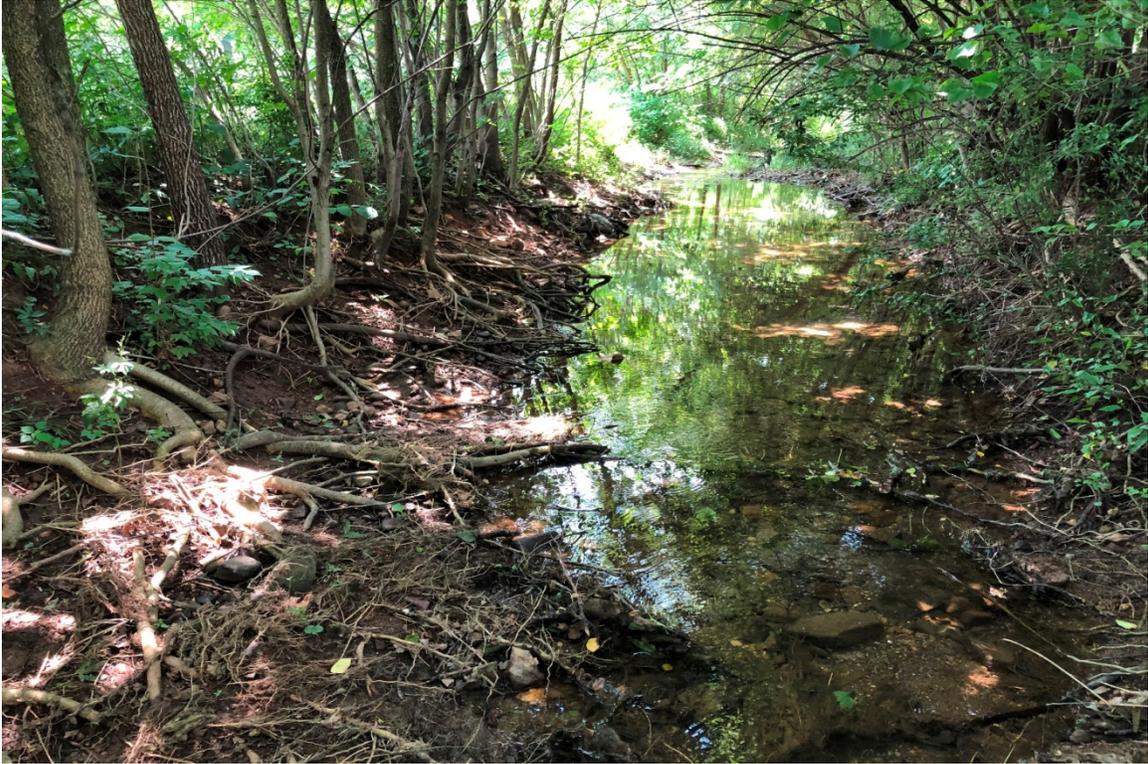
Tree roots exposed along entire left bank
