**Snitz Creek 4 Stream Restoration and Stormwater Retrofit Project
Cornwall Borough, Lebanon County, Pennsylvania**

**Pennsylvania Department of Environmental Protection
Growing Greener Plus Grants**

December 2019

Snitz Creek #4 Stream Restoration and Stormwater Retrofit Project Detailed Project Description

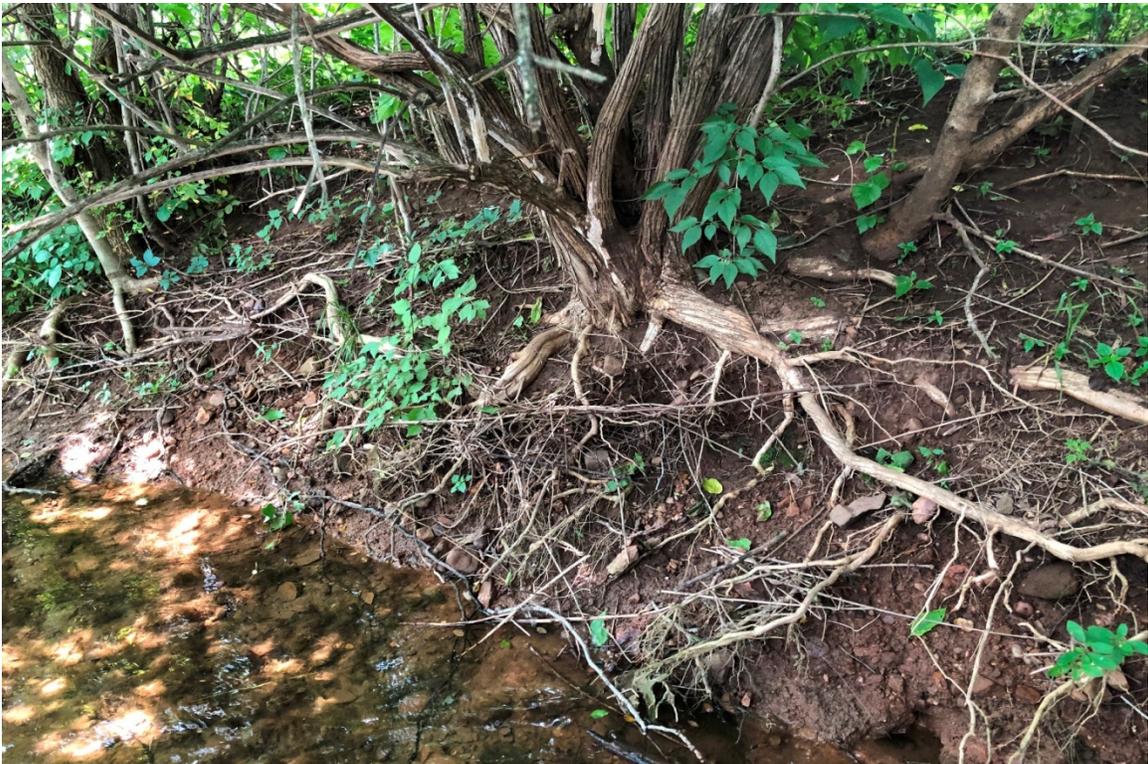
Erosion and undercut trees along right bank

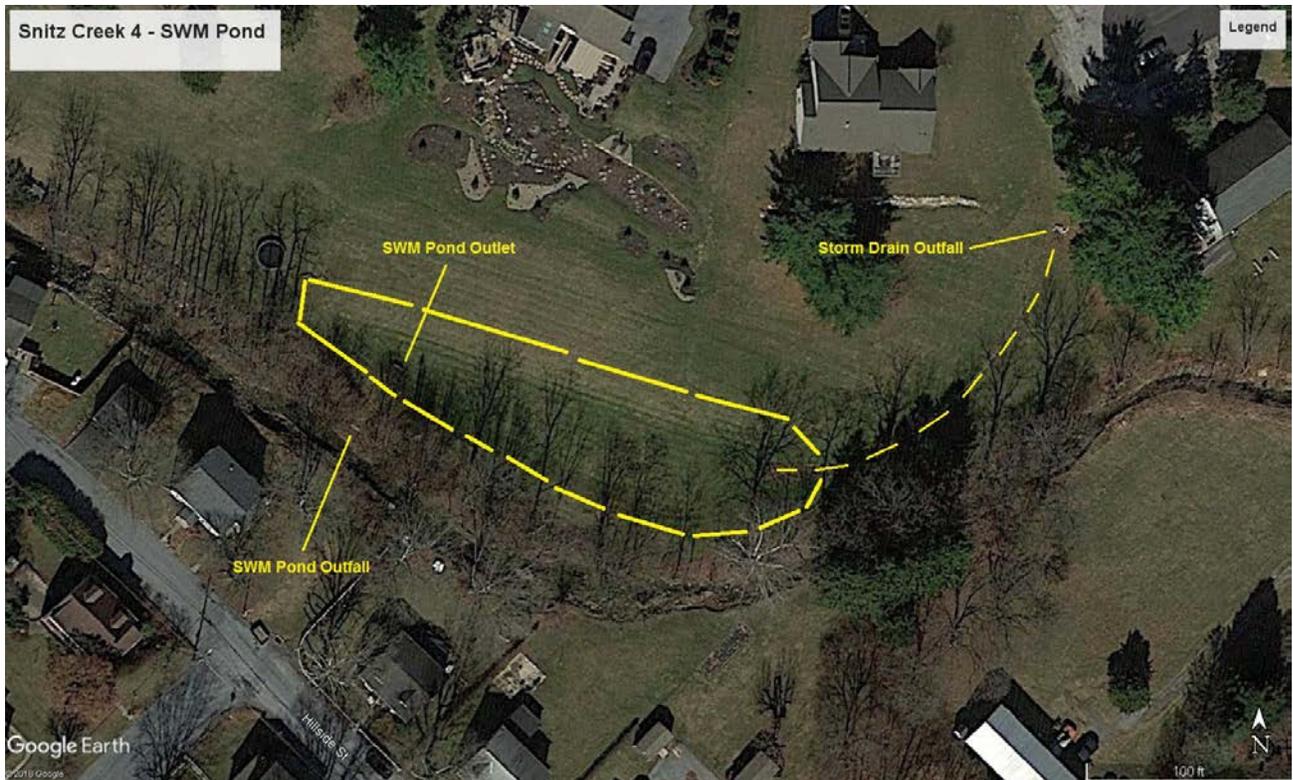
Aerial photograph shows existing Cornwall Hills SWM pond with discharge into Reach 2

- Modify existing dry detention pond serving Cornwall Hills Subdivision along Reach 2 to create extended detention pond and/or bioretention to provide water quality management of runoff from subdivision.
- Existing storm drain outfall below Cornwall Hills Drive and rip-rapped stormwater conveyance swale into pond will not be disturbed.

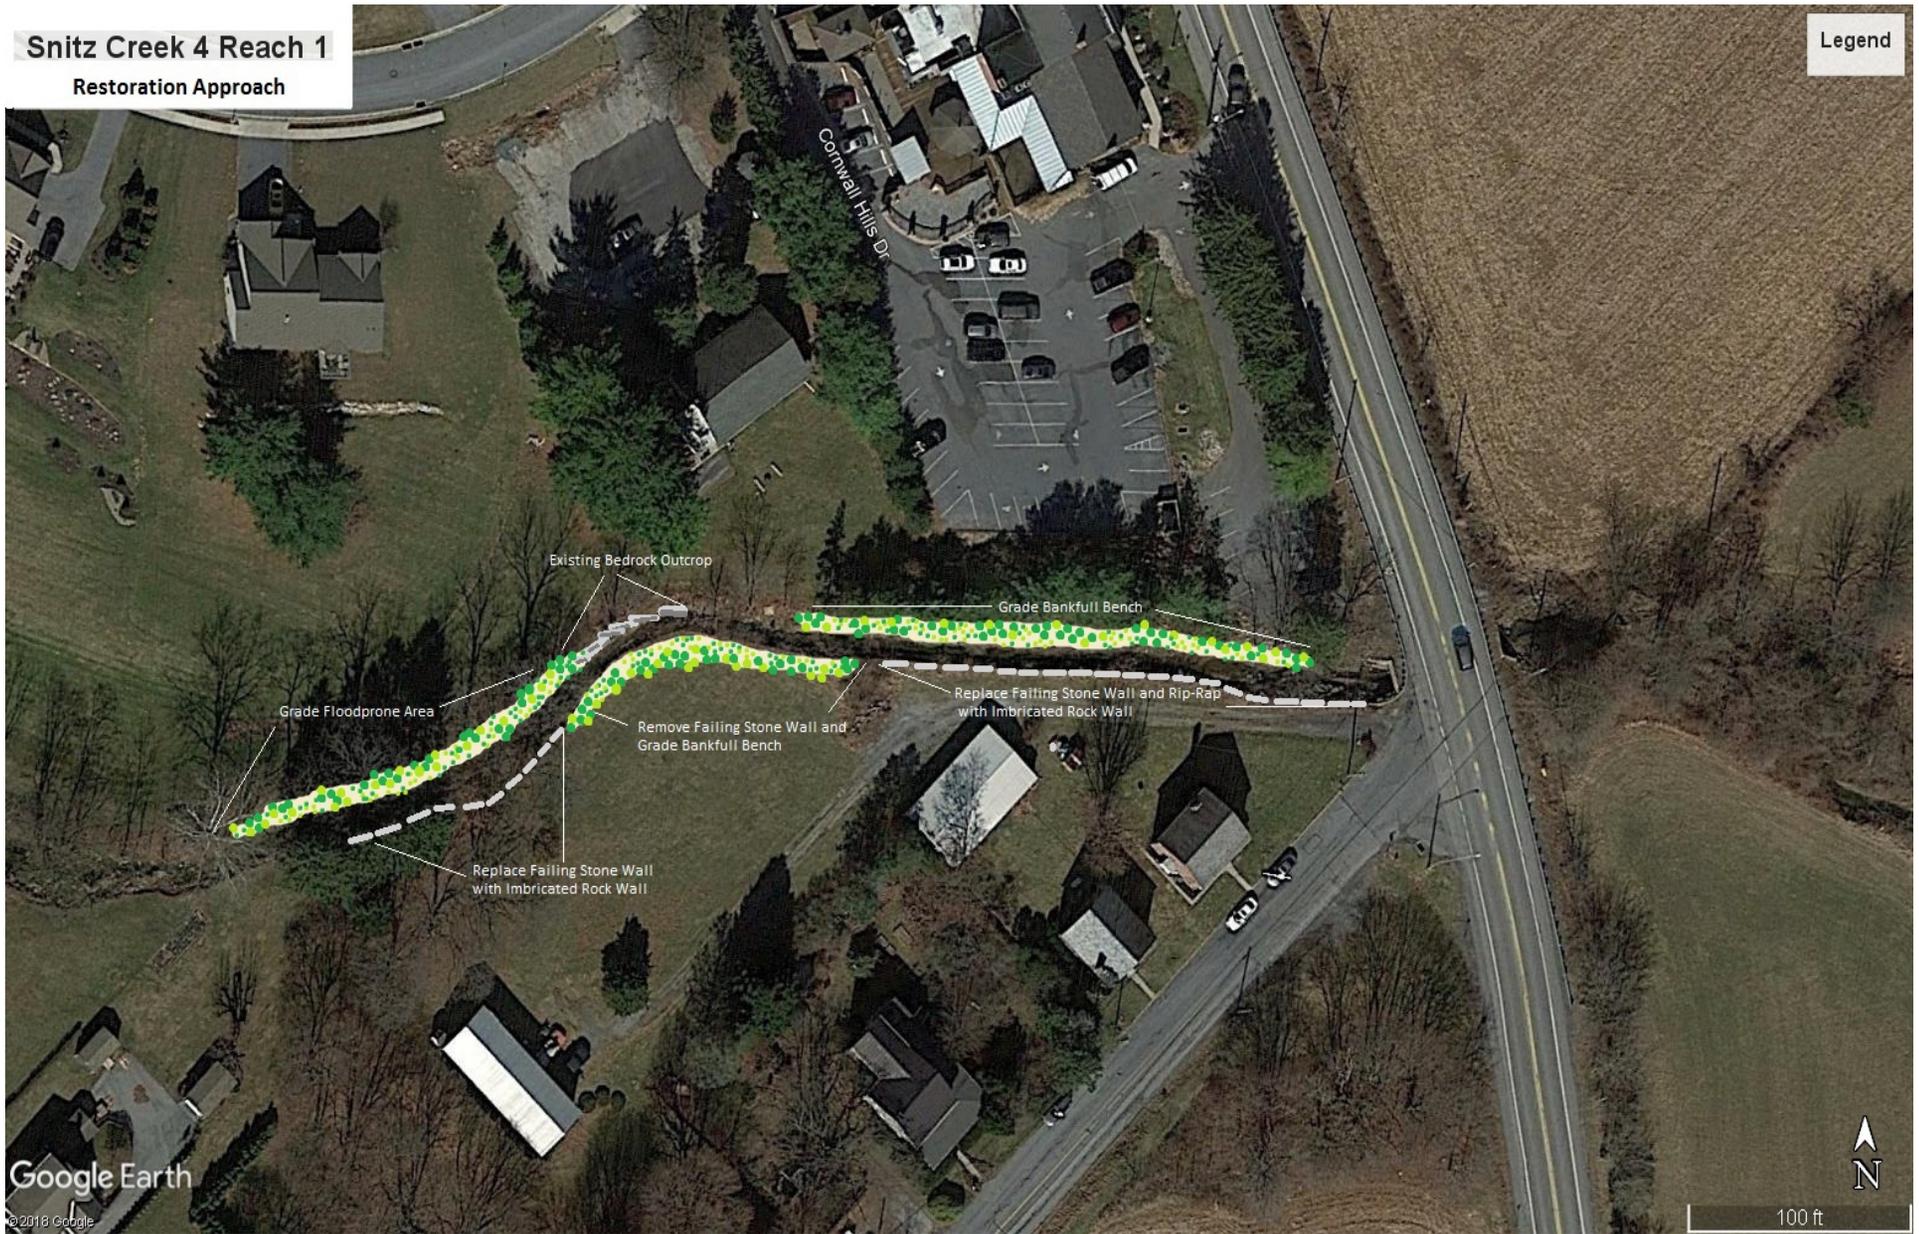
Snitz Creek 4 Reach 1 Restoration Approach

The restoration approach for Reach 1 will involve:

- Removing existing debris jams and junk from the channel;
- Replacing the failing stone wall from the left bank along the upper section with an imbricated rock wall.

- Removing the rip-rap and rubble from the right bank along the upper section and grading a bankfull bench to alleviate the confinement and provide flood relief.

- Removing the failing stone wall from the left bank along the middle section and grading a bankfull bench to alleviate the confinement and provide flood relief.

- The existing rock outcrop along the right bank along the middle section will be left undisturbed.
- Replacing the failing stone wall and rubble from the left bank along the lower section with an imbricated rock wall.

- Grading a floodprone area along the right bank to alleviate the confinement and provide flood relief.
- The newly constructed streambanks and floodprone areas will be stabilized by seeding with native grasses and planting with native trees and shrubs.

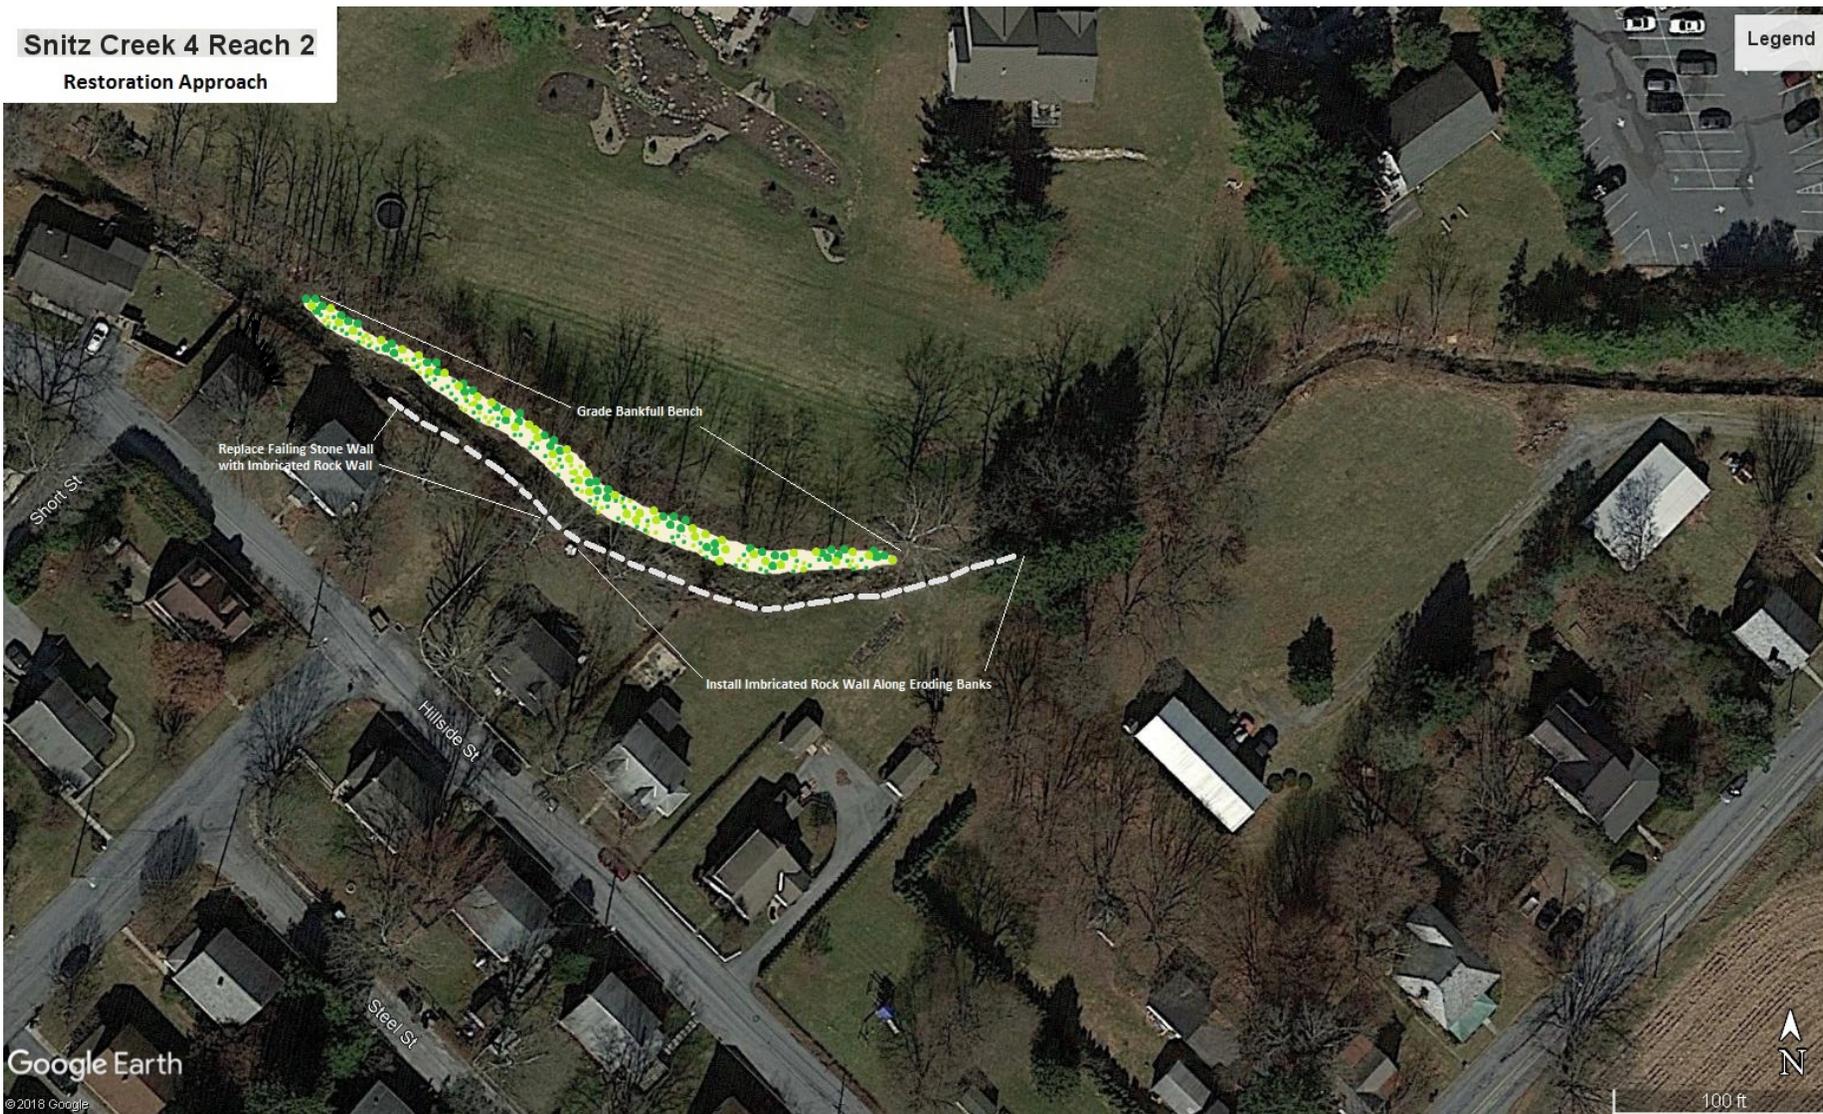
Snitz Creek 4 Reach 2 Restoration Approach

The restoration approach for Reach 2 will involve:

- Installing an imbricated rock wall along the eroding left banks.
- Grading a bankfull bench along the right bank to alleviate the confinement and provide flood relief.
- The newly constructed streambanks and floodprone areas will be stabilized by seeding with native grasses and planting with native trees and shrubs.

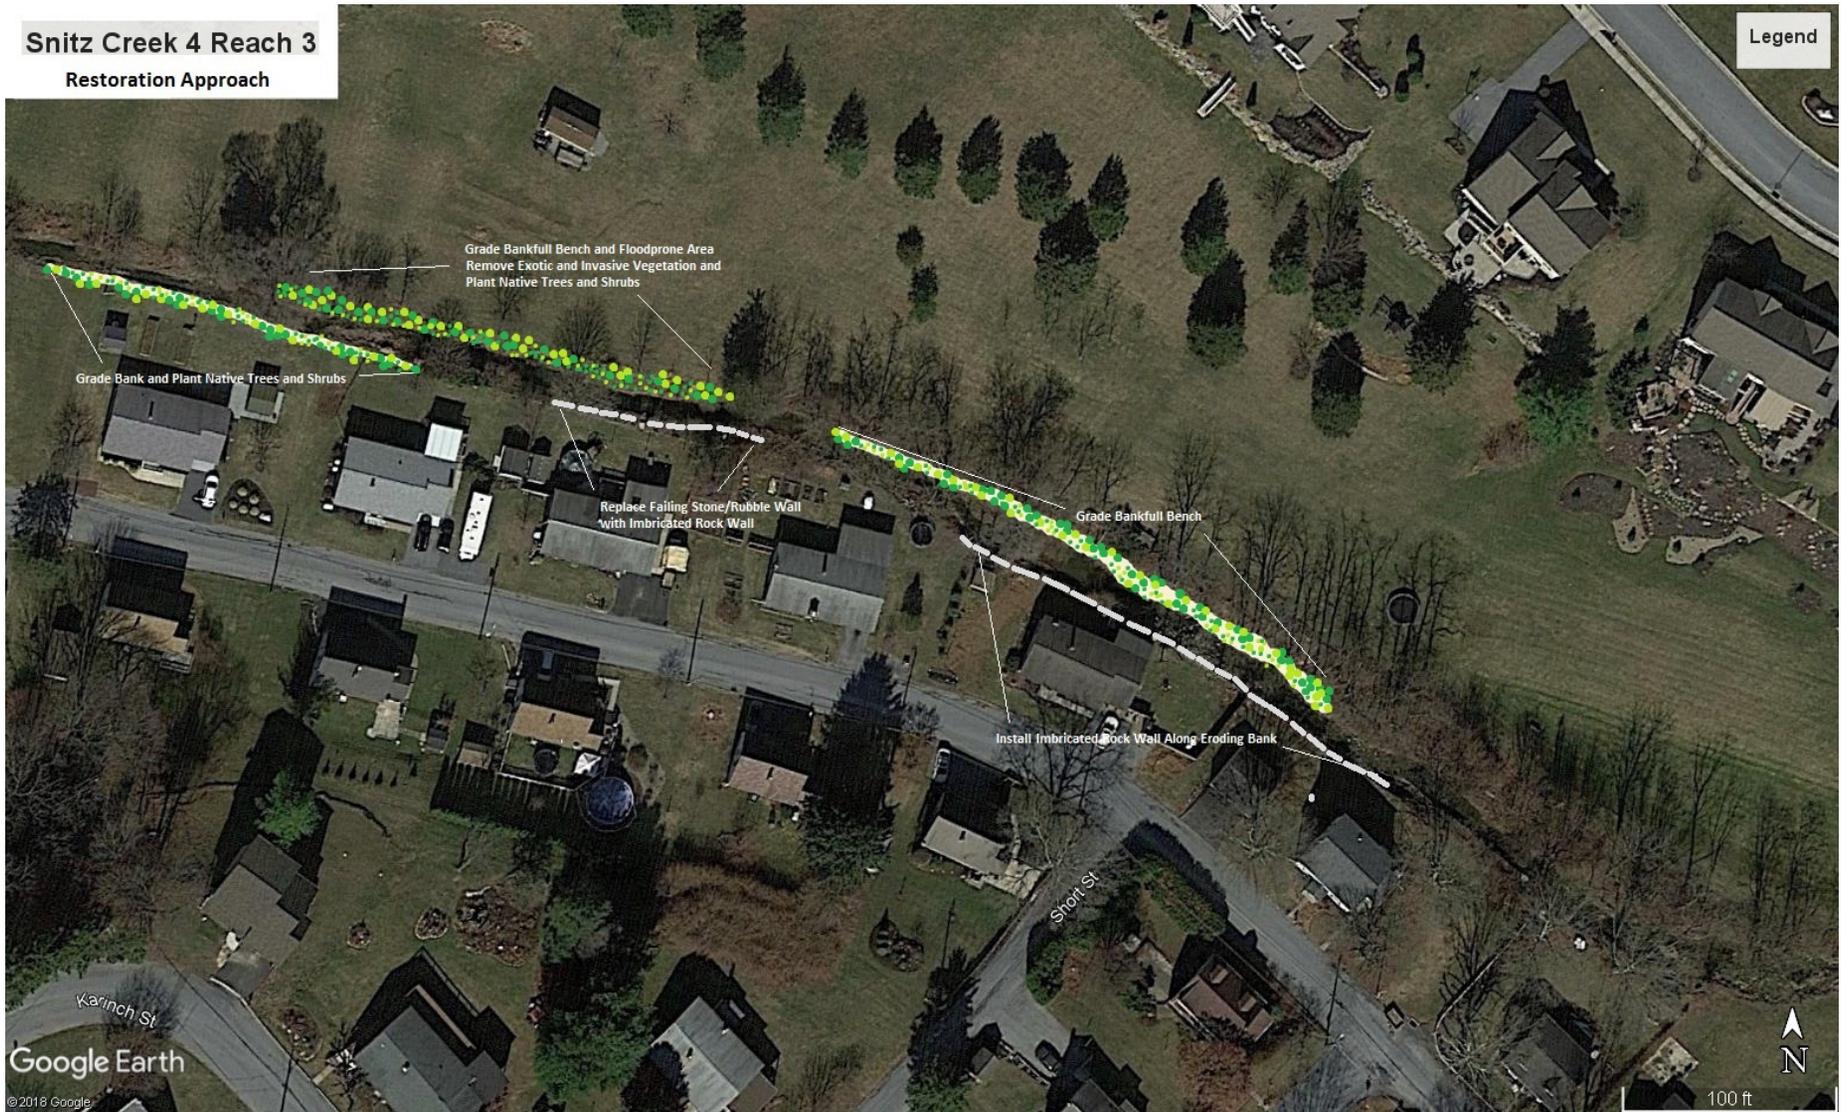
Snitz Creek 4 Reach 3 Restoration Approach

The restoration approach for Reach 3 will involve:

- Removing existing debris jams and junk from the channel;
- Installing an imbricated rock wall along the eroding left bank along the upper section.
- Grading a bankfull bench along the right bank along the upper section to alleviate the confinement and provide flood relief.
- Replacing the failing stone wall and rubble from the left bank along the middle section with an imbricated rock wall.
- Remove exotic and invasive vegetation along the right bank along the middle and lower section and planting with native trees and shrubs.
- Grading a floodprone area along the right bank to alleviate the confinement and provide flood relief.
- Narrow overwide sections by installing toe benches along channel margin.

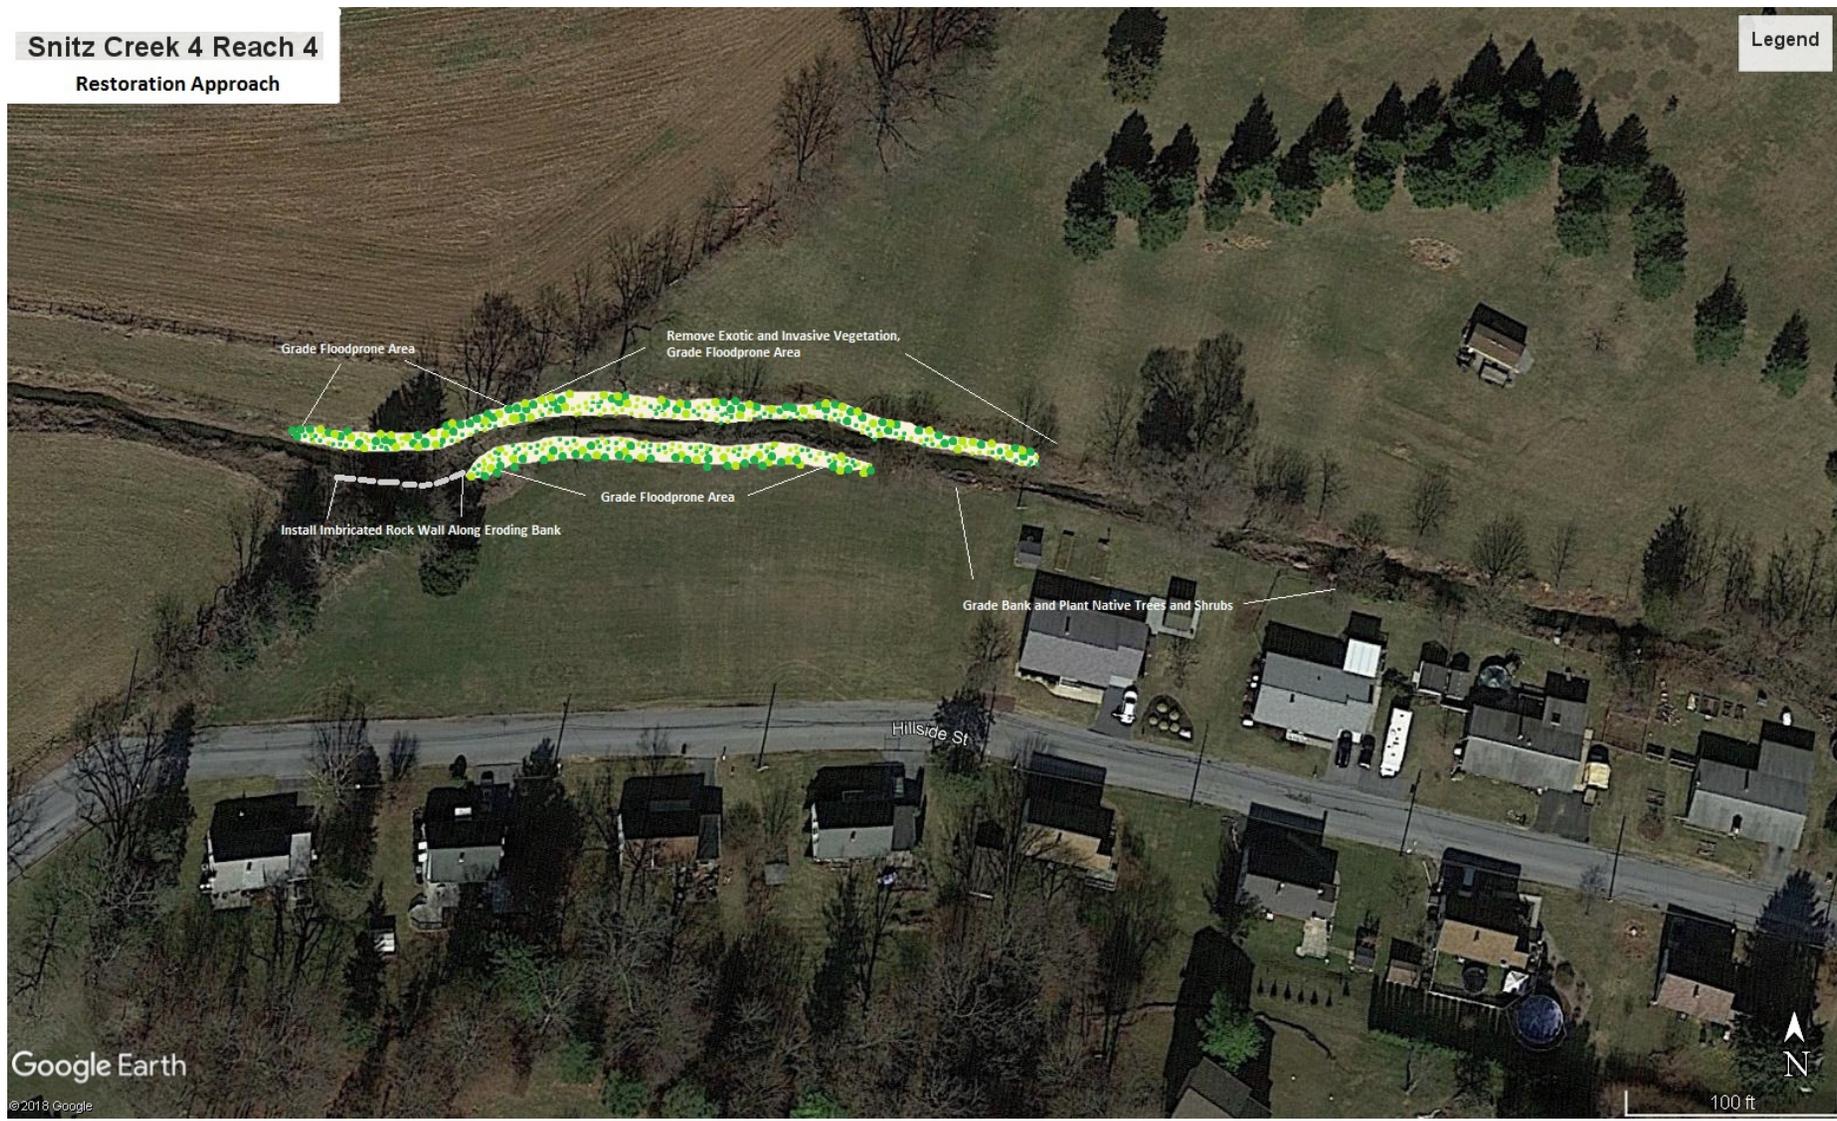
Snitz Creek 4 Reach 4
Restoration Approach

The restoration approach for Reach 4 will involve:

- Remove exotic and invasive vegetation along the right bank along the upper and middle section
- Grading a floodprone area along the right bank to alleviate the confinement and provide flood relief.
- Grading a floodprone area along the left bank to alleviate the confinement and provide flood relief.
- Narrow overwide section by installing toe benches along channel margin.
- Along the tight, confined bend at the downstream end of the reach, installing an imbricated rock wall along the eroding left bank, removing trees along right bank and grading a floodprone area to alleviate the confinement and provide flood relief.
- The newly constructed streambanks and floodprone areas will be stabilized by seeding with native grasses and planting with native trees and shrubs.

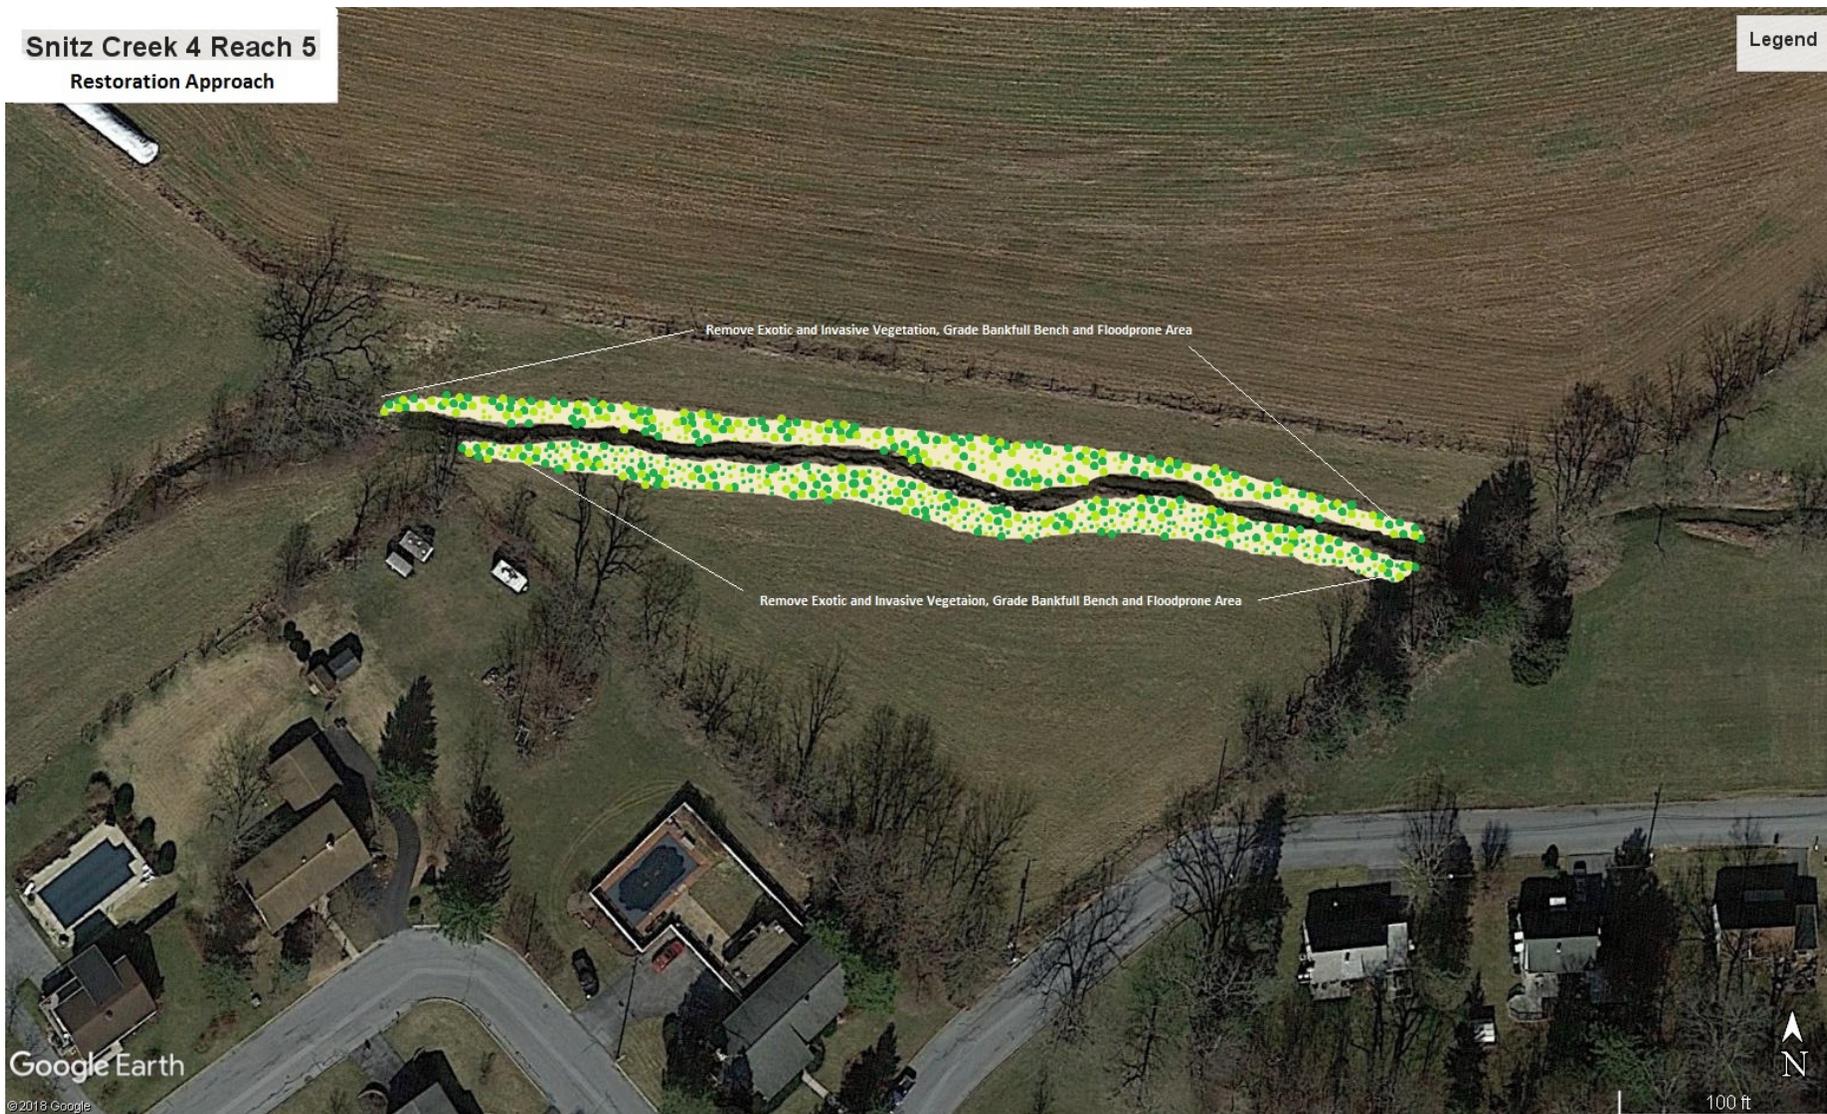
Snitz Creek 4 Reach 5
Restoration Approach

The restoration approach for Reach 5 will involve:

- Removing exotic and invasive vegetation along both banks along the entire reach.
- Grading a floodprone area along both banks along the entire reach to alleviate the confinement and provide flood relief.
- Narrow overwide sections by installing toe benches along channel margin.
- The newly constructed streambanks and floodprone areas will be stabilized by seeding with native grasses and planting with native trees and shrubs.

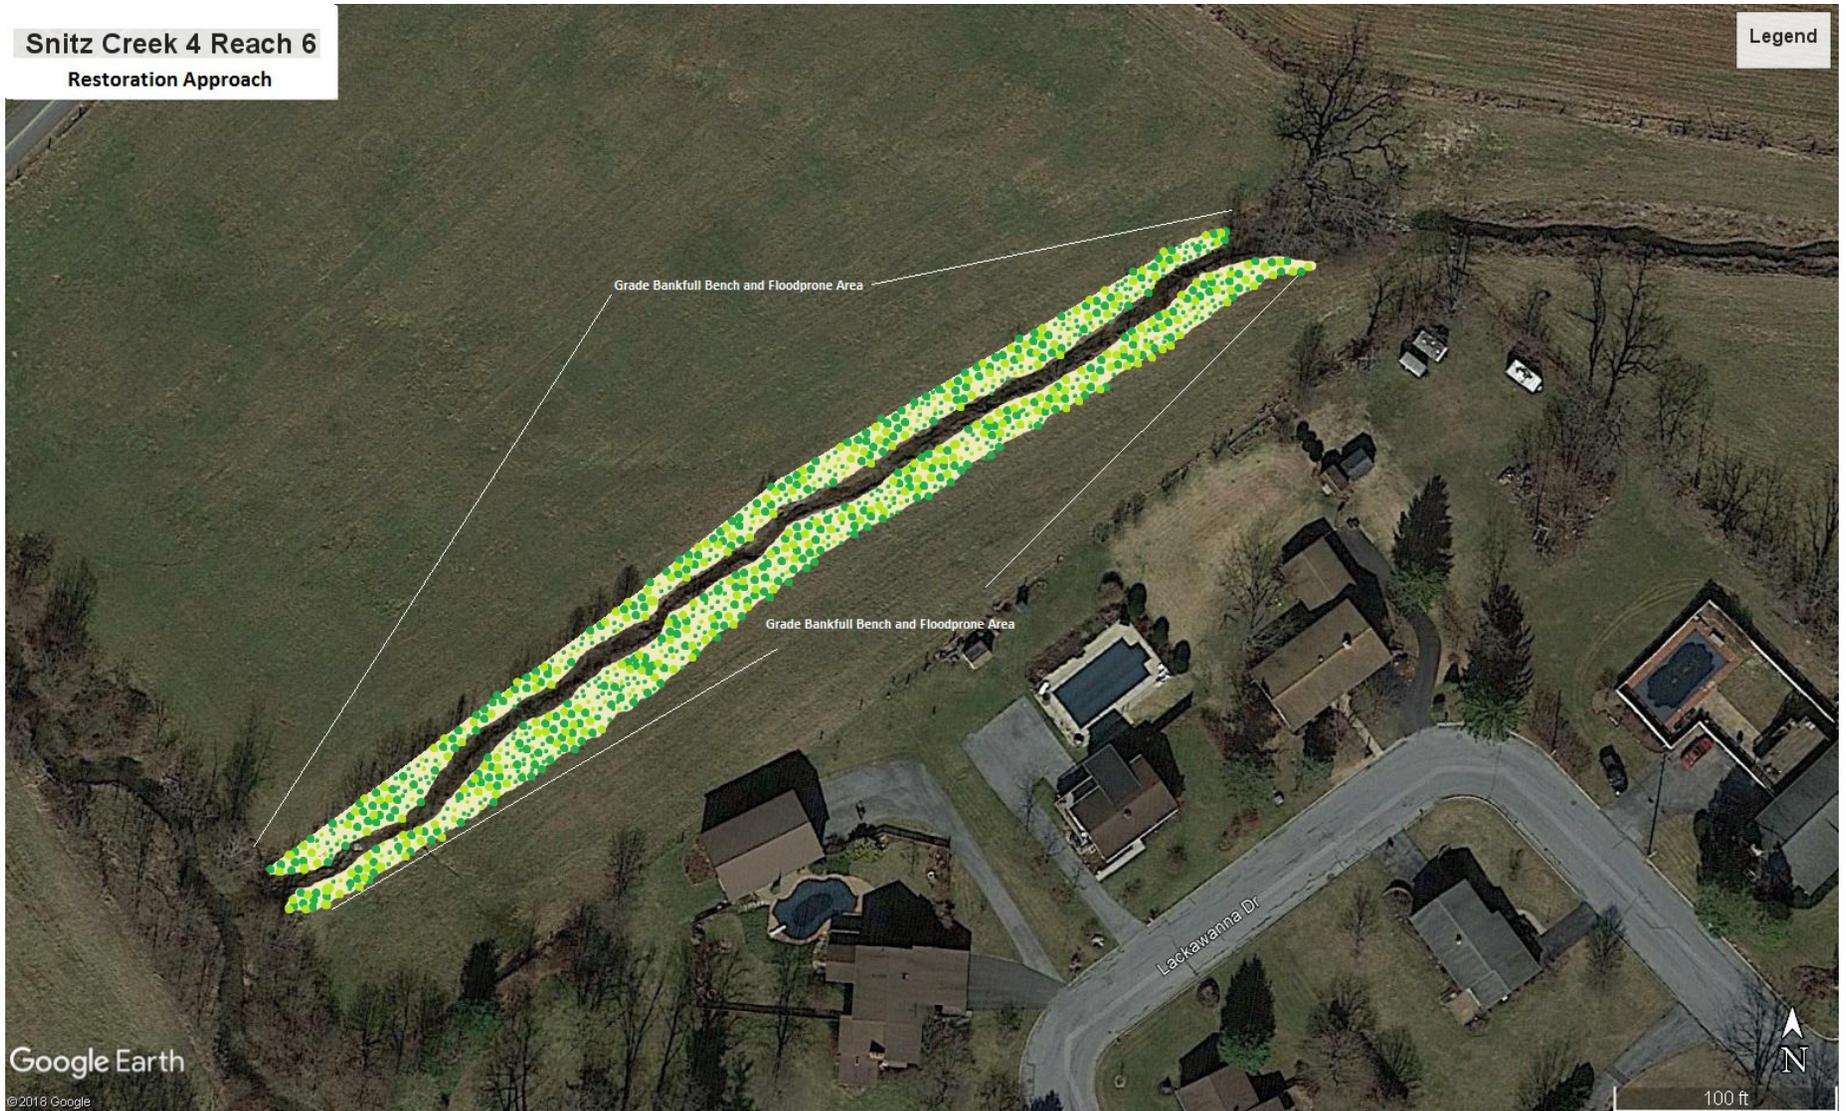
Snitz Creek 4 Reach 6
Restoration Approach

The restoration approach for Reach 6 will involve:

- Grading a bankfull bench and floodprone area along both banks along the entire reach to alleviate the confinement and provide flood relief.
- Narrow overwide sections by installing toe benches along channel margin.
- The newly constructed streambanks and floodprone areas will be stabilized by seeding with native grasses and planting with native trees and shrubs.
